# Investigation Report

Type of Occurrence:	Accident
Date:	24 August 2008
Location:	Munich
Aircraft:	Transport aircraft
Manufacturer / Model:	ATR-GIE Avions de Transport Regional / ATR 72-212A
Injuries to Persons:	One passenger seriously injured, one crew member slightly injured
Damage:	Aircraft severely damaged
Other Damage:	None
Information Source:	Investigation by BFU
State File Number:	BFU AX003-08

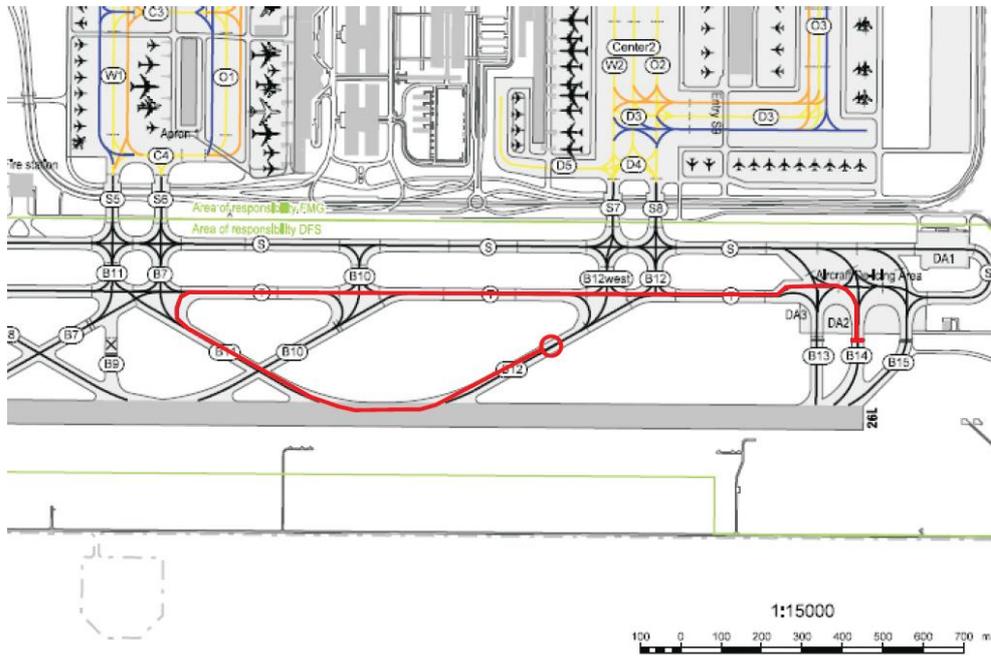
Appendix 1 Taxiway plan

At 1954 hrs<sup>1</sup> the ATR was stationary at taxi hold point B12 when it was given clearance to enter runway 26L. The clearance was given immediately after an Airbus A320 had commenced its take-off run on runway 26L. Twenty seconds later, the ATR was cleared for take-off from runway 26L and confirmed receipt of the message. Forty seconds later the tower asked the ATR to begin the take-off run, because otherwise another aircraft then on approach would have to go around. The ATR confirmed the immediate commencement of the take-off run. Six seconds later the tower instructed the ATR to abort the take-off: "[Call sign] disregard departure clearance vacate first high-speed to the right again." The ATR followed the instruction and was then cleared via taxiway T to return to taxi hold point B14 for runway 26L. (see appendix).

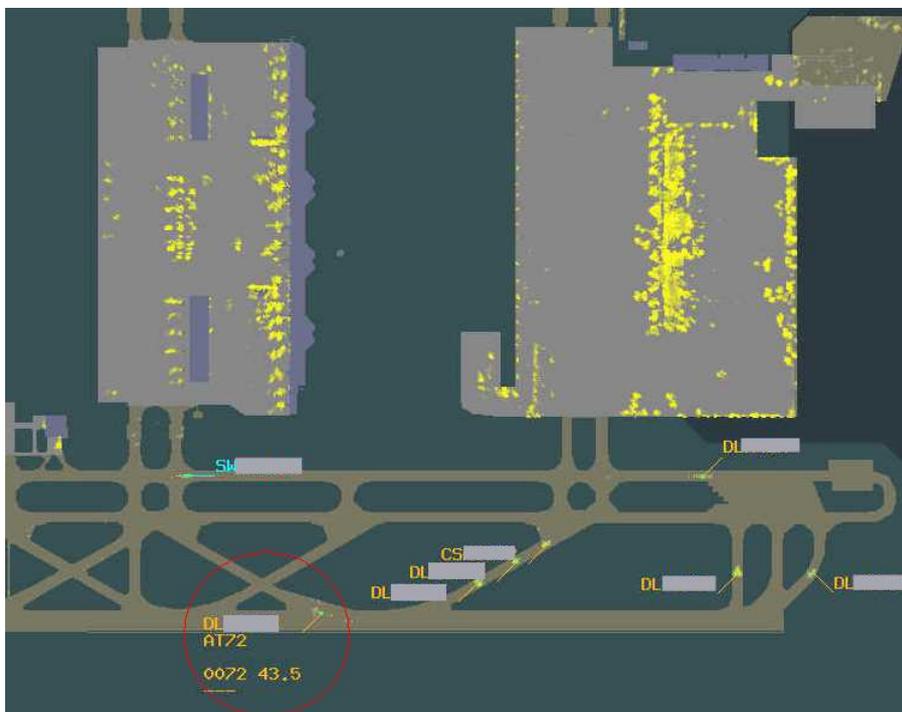
Appendix 2 Ground radar trace

During taxi, the ATR was followed and recorded by ground radar (ASMR). Extracts from the recordings were available to the BFU for evaluation and are depicted in the appendix.

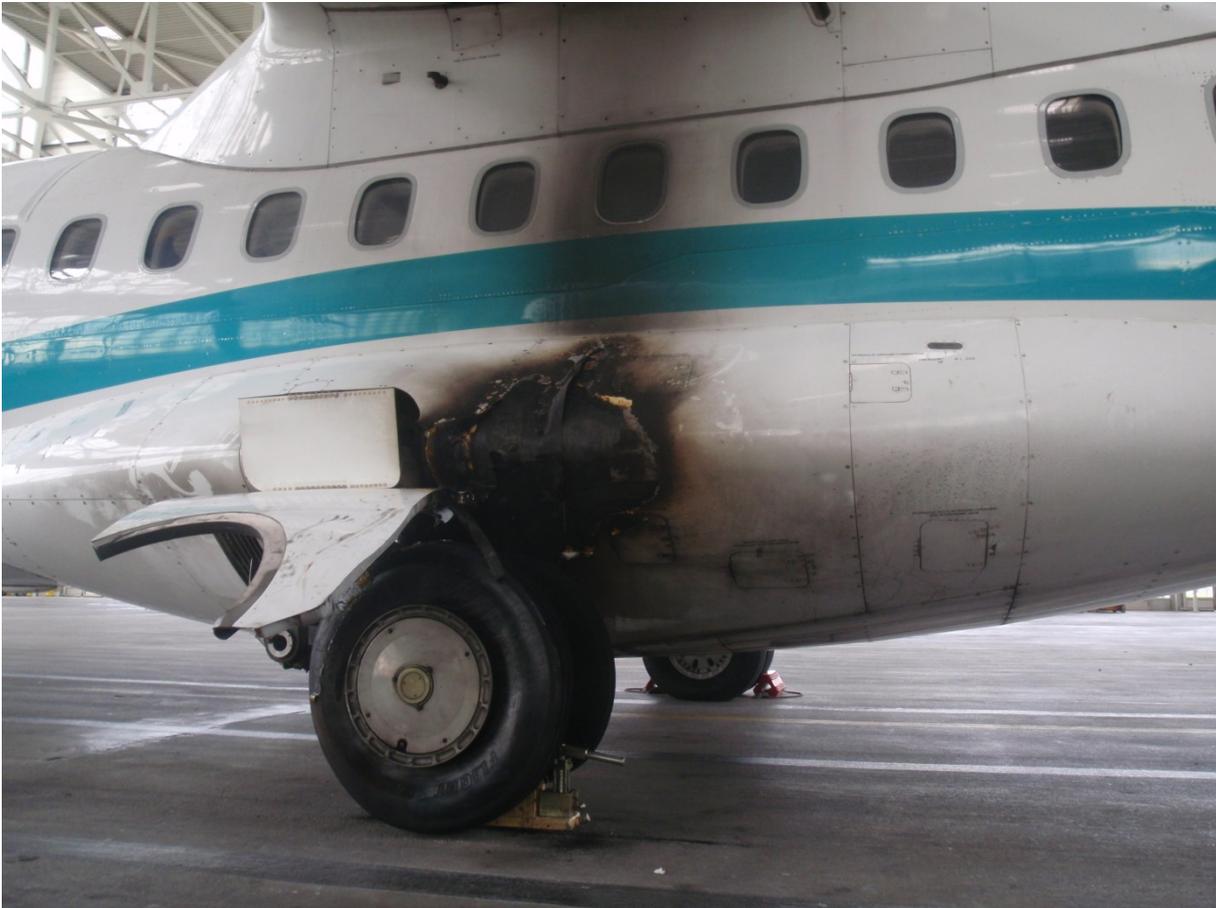
Appendix 3 Damage to aircraft

Damage to the aircraft related to the left main landing gear and the surrounding fuselage fairing (see photo).

Examination of the left landing gear showed that a brake cylinder on the inner wheel of the left landing gear had ruptured. Two others had been deformed. The brake was examined in detail at the component manufacturer in the presence of the French safety investigation authority BEA, and the examination revealed that the damages had been caused by overheating. A thermal analysis determined that normal taxiing

to the runway, rejected take-off, and the taxiing back to the taxi hold point could not heat up the brake to an extent which would cause the found damages.

Inspection of the aircraft on-site revealed that fire started on the inner of the two tyres on the left main landing gear. The fire then spread to the outer tyre and the landing gear fuselage fairing immediately above. The fuselage area above the landing gear was blackened by soot.
