# **AGENZIA NAZIONALE PER LA SICUREZZA DEL VOLO**

## **FINAL REPORT**

**ACCIDENT INVOLVED AIRCRAFT  
BOEING MD-87, registration SE-DMA  
and CESSNA 525-A, registration D-IEVX  
Milano Linate airport  
October 8, 2001**

**N. A/1/04**

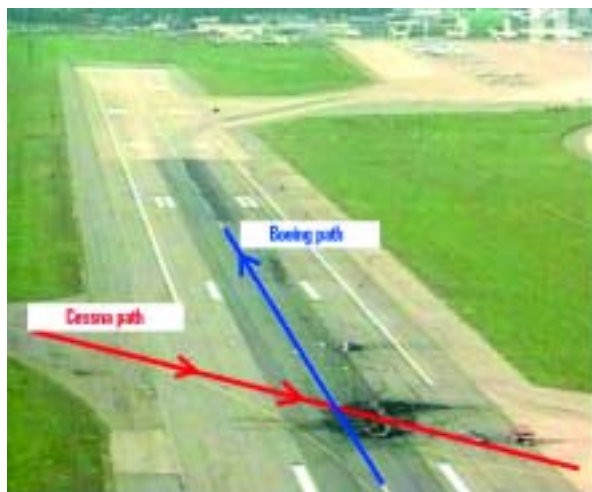
Photograph 1 - Aircraft trajectories.

At collision time the Cessna was crossing RWY 18L/36R with an estimated heading of  $135^{\circ}$  ( $\pm 10^{\circ}$ ), while the MD-87, keeping the runway heading, was performing a normal takeoff rotation (see photograph 1).

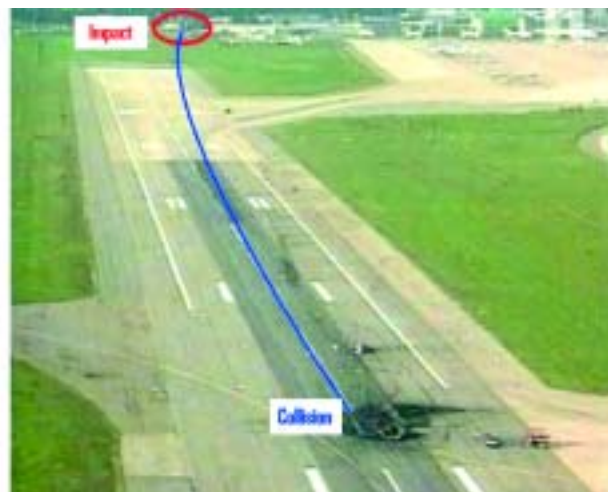
Photograph 2 - Boeing MD-87 path after the collision.

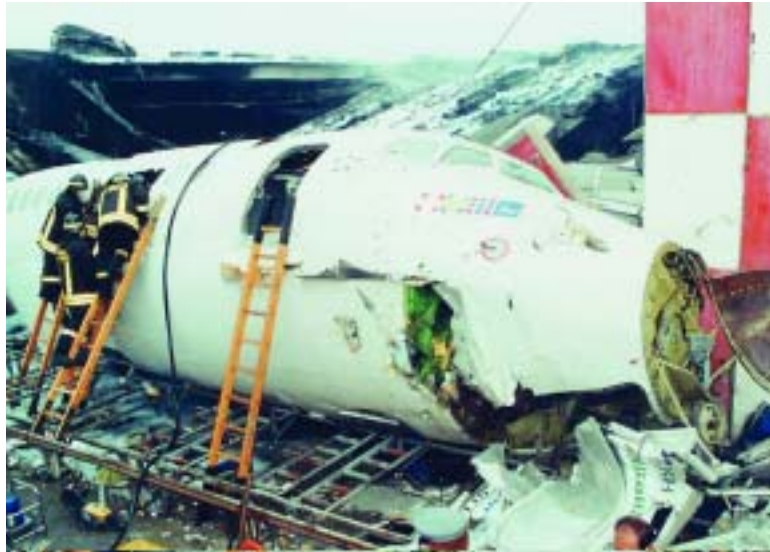
The empennage broke off forward of aft pressure bulkhead when hitting a corner and was stopped outside the building.

The fuselage stopped instantly and the complete wing assembly detached from the fuselage and continued into the building. The fuel contained in the central section and the wings spread and burst into fire. The tip of LH wing broke and slid beyond the left corner of the building without being ingested by fire. The horizontal stabilizer continued to travel further away and finally came to rest on top of the building. LH engine heavily damaged, was located close to the fuselage with the reverse thrust buckets deployed.

Photograph 3 – MD-87 fuselage.

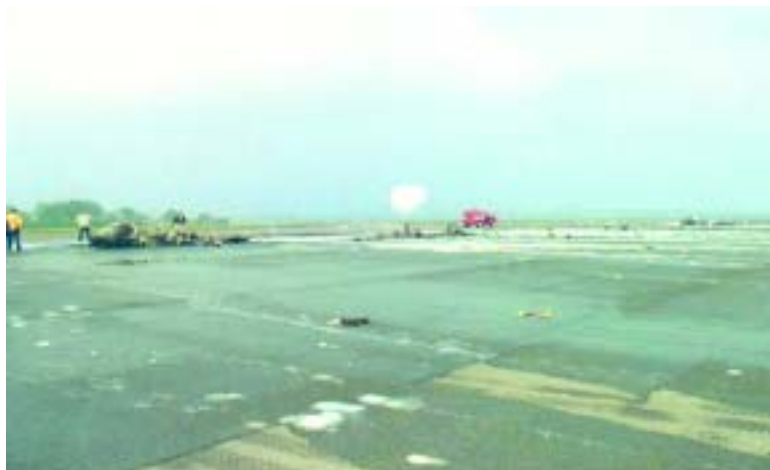
Both horizontal stabilizers were separated from the empennage

Photograph 4 – The Cessna wreckage on the runway.

and were lying on the runway. The major part of the RH elevator remained connected to the RH stabilizer. The LH stabilizer and elevator showed signs of collision on their lower side.

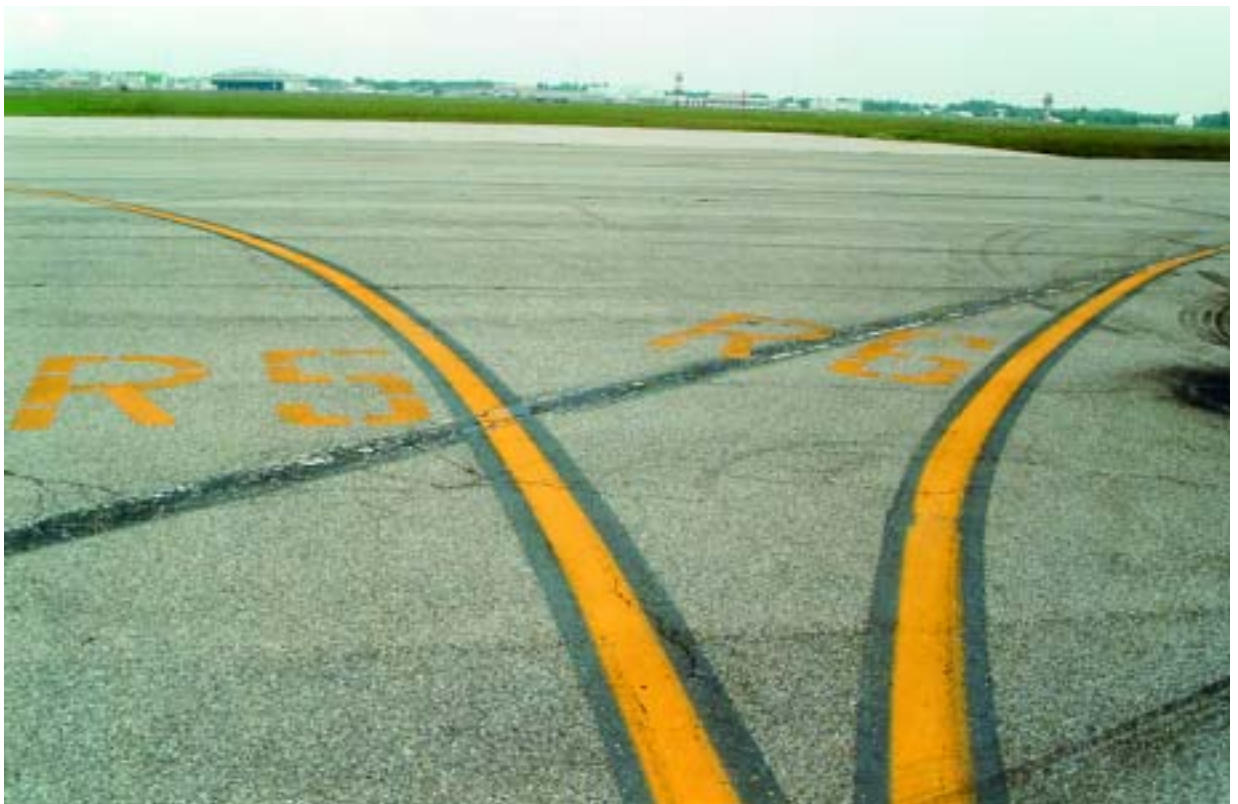
A yellow taxi line runs for the whole length of the West apron (joining TWY R5 and TWY R6 centerlines). Along the sides of that taxi line there were six parking stands numbered from 51 to 56, regularly marked by lead-in yellow lines as indicated on the map. The parking stands were North of a refueling station, which was not reported on any official map or document. South of the refueling station there were another six parking positions each with a lead-in yellow line (orthogonal to the central taxi line); they were not marked (no numbering identification). The six parking stands faced a hangar of ATA. These lines all lead to a further yellow line (parallel to the central taxi line) which continued turning South-East so as to join with the central taxi line. The yellow taxi line just described, lead aircraft southerly then easterly to a position where it was possible to continue either towards TWY R5, leaving the West apron towards the North or towards TWY R6, leaving the West apron towards South-East (see photograph 5).

Photograph 5 - Taxiway selection for TWY R5 or TWY R6.

At the branching where the line parted there were markings painted in yellow showing R5 and R6 respectively, to the left of each line. The characters painting was worn out and they did not conform to the color, form or proportions as described in ICAO (Annex 14, Chapter 5.2.16.4.b and appendix 3 and/or 4).

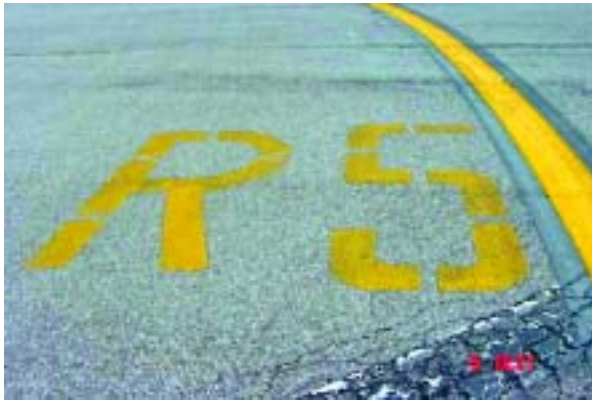
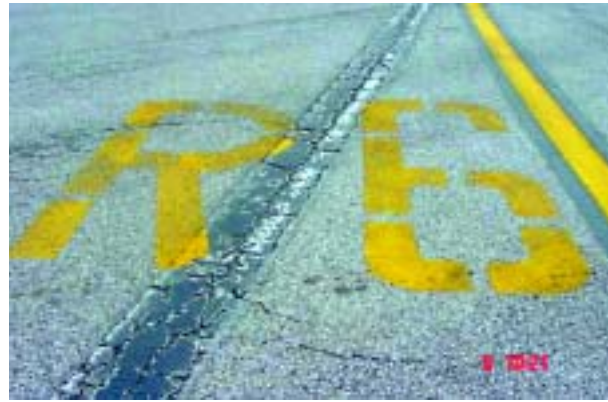
Photograph 6  
Marking showing direction TWY R5.

Photograph 7  
Marking showing direction TWY R5.

Where the yellow taxi line curved (at the split), the markings were positioned to the left of the lines and on a slanted angle from the pilot viewpoint (see photographs 6 and 7).

- c) the alphanumeric markings at the partition point, were the yellow line exited the parking position in front the ATA hangar, leading to R5 or R6, were not in conformity with ICAO Annex 14 (Chapter 5.2.16.4.b);
- d) the markings were partially worn and positioned at an angle (slanted) from the pilots' perspective, they could be confused with each other;

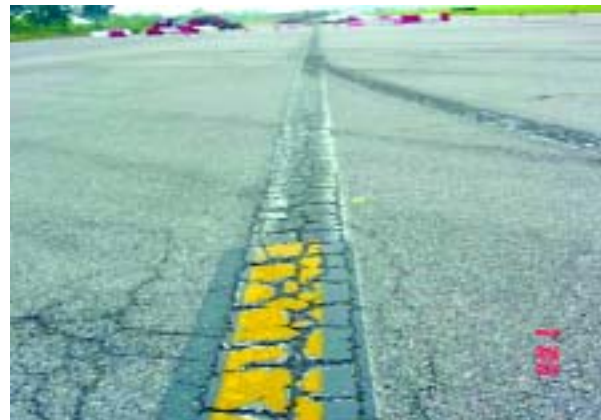
The yellow line leading towards South-East was partially worn out and it had been intermittently covered with black paint (to cover an old path that had been modified), thus resulting in a non-uniform line (see photograph 8).

Photograph 8 – Discontinued path marking.

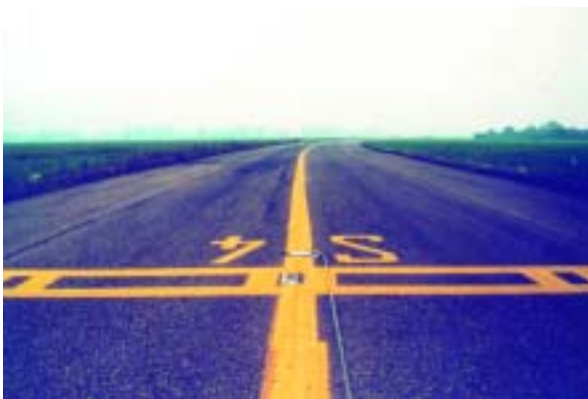
Photograph 9 - S4 marking and ICAO pattern B runway - holding.

No documentation was found signaling the existence of/or regulating the operational intended meaning of such S1-S5 markings and of their position. No documentation has been found instructing SEA to enforce the decision and to activate the placement (painting) of the markings.

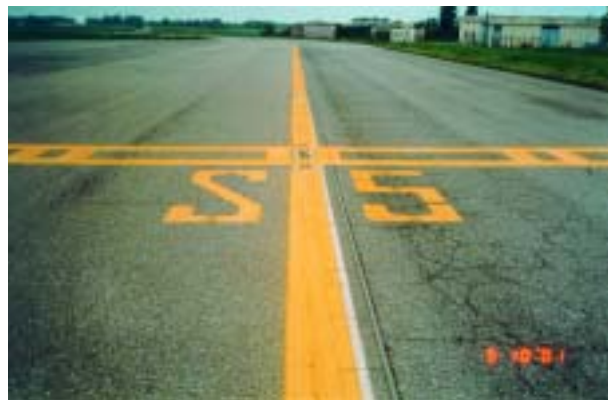
Photograph 10 - S5 marking and ICAO pattern B runway - holding.

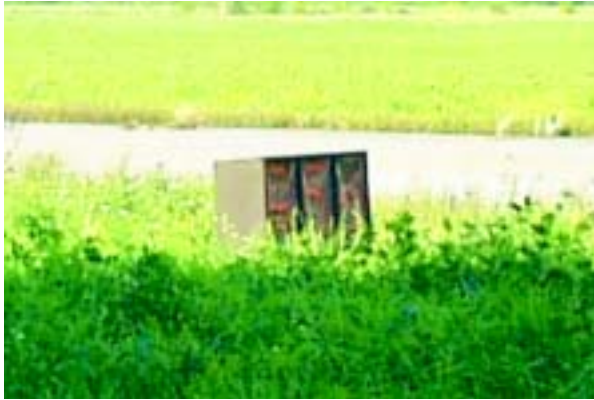
Photograph 11 - Location sign at TWY R5 entrance (exiting West apron).

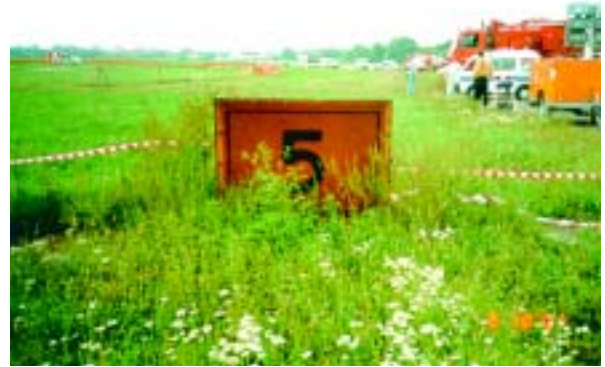
Taxiing from the North apron towards TWY R5, a vertical non illuminating location sign showed the indication **5** in black on red background to the left of the taxiway. This sign was partially covered with tall grass growing in front of it (see photograph 12).

Photograph 12 - Location sign at TWY R5 entrance (exiting North apron).

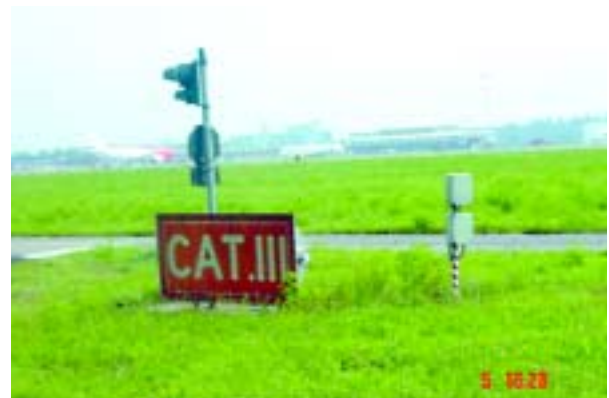
Photograph 13 – CAT III vertical sign on TWY R6.

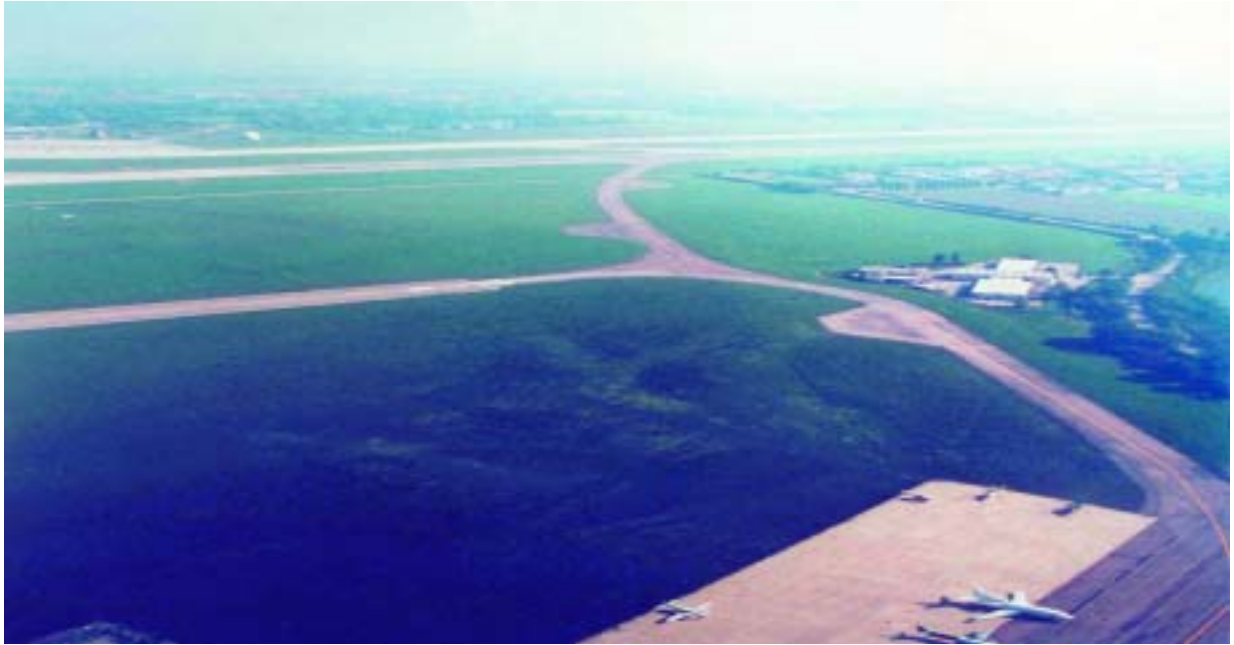
Photograph 14 - West apron aerial photograph (lower side).
