# Investigation Report

Type of Occurrence:	Accident
Date:	2 June 2006
Location:	Hamburg
Type of Aircraft:	Fixed Wing
Manufacturer / Model:	De Havilland / DCC 2
Injuries to Persons:	Five occupants fatally injured One occupant seriously injured
Damage to Aircraft:	Aircraft destroyed
Other Damage:	Damage to railway tracks and freight cars
Source of Information:	Investigation by BFU
State File Number:	BFU 3X083-06

Bundesstelle für  
Flugunfalluntersuchung

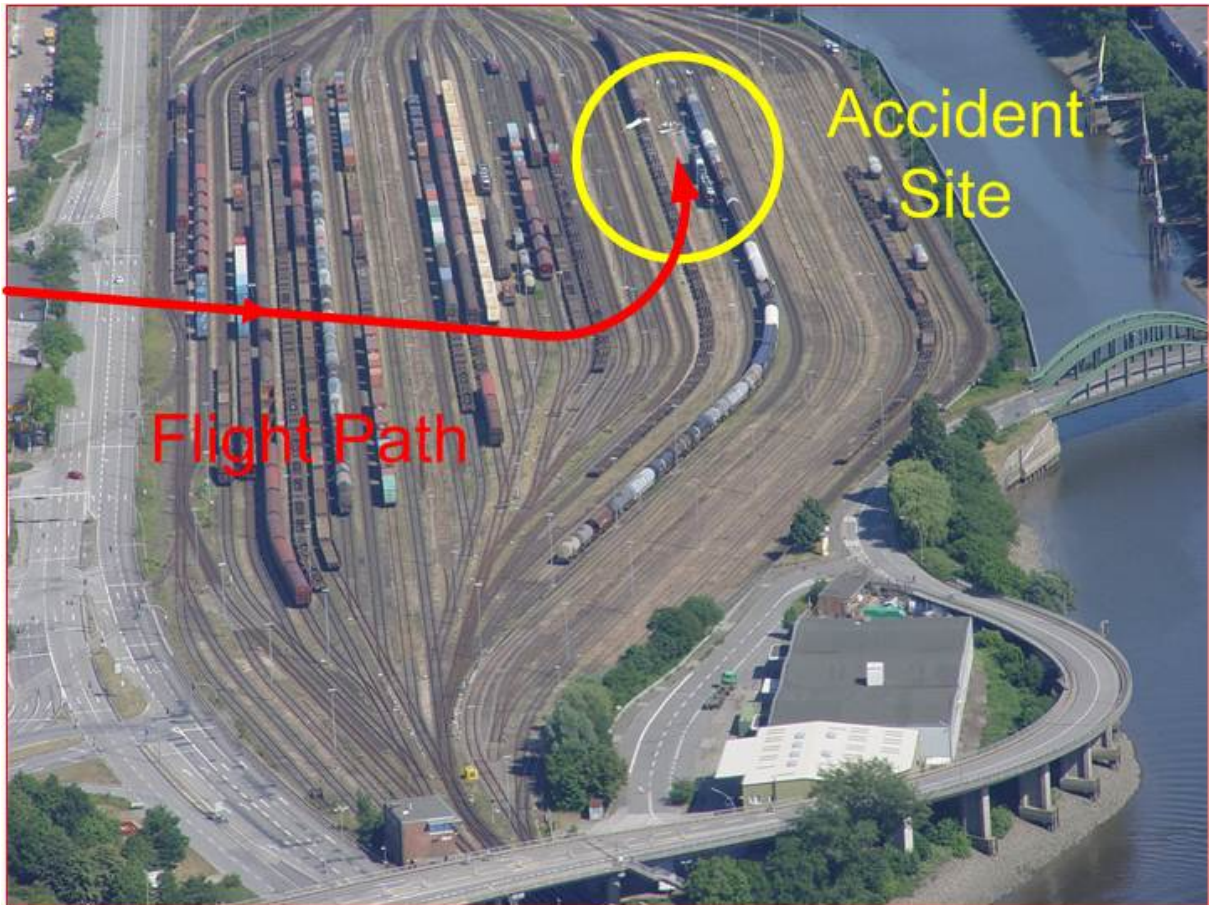
Picture 5: Accident site on the railway goods marshalling yard

The point at which the seaplane first made contact with the ground was indicated by glass fragments from the seaplane navigation lights and sheet metal shards from the right wing found on a railway track. Both seaplane floats were ripped away from the fuselage and came to rest on a goods wagon standing on a parallel railway track. The main wreckage consisted of the fuselage, motor, tailplane and both wings, and came to rest in the direction of flight on yet another parallel railway track. The main wreckage was inverted.

One blade tip on the three-blade propeller was shortened and the rest of that blade was bent slightly rearwards. The other propeller blades bore no unusual traces of deformation.

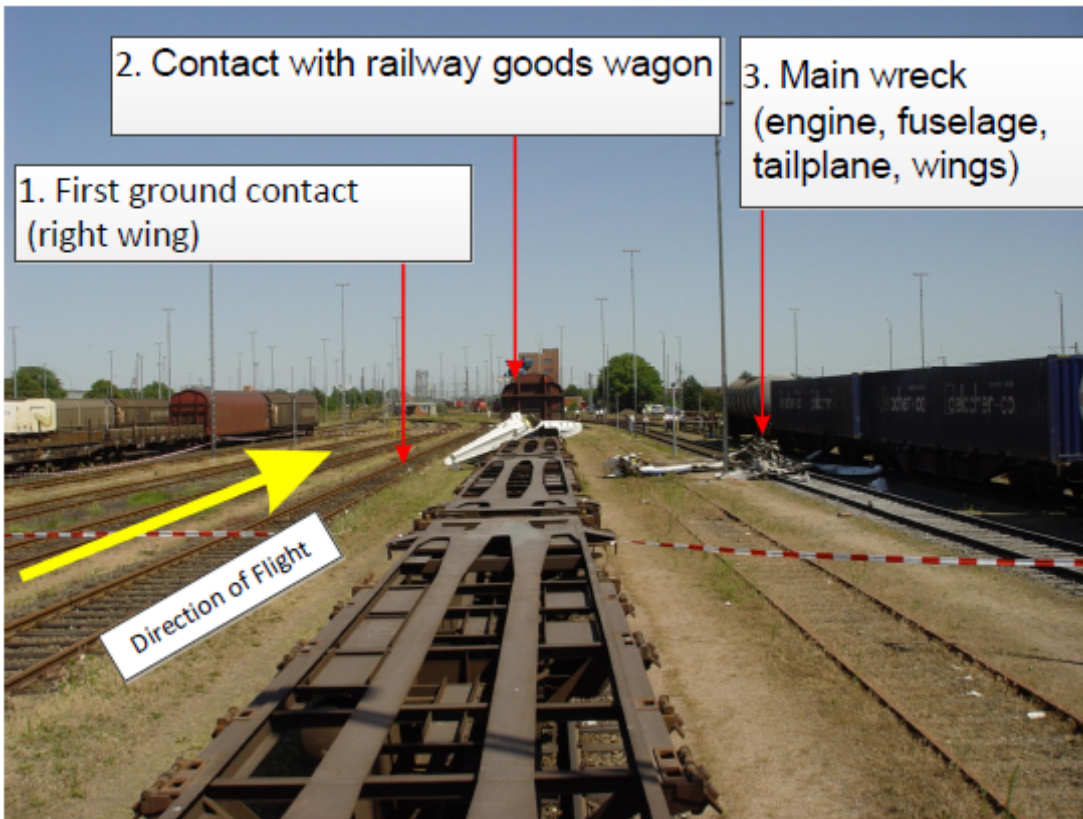
Picture 6: Impact points and wreck distribution

The wreckage pattern indicated that the aircraft had been flying on a track of  $100^\circ$  immediately prior to impact. Witness statements and the wreckage pattern agreed that the right wingtip made first contact with the railway track; the aircraft attitude was then about  $10^\circ$  nose down and about  $45^\circ$  right wing down.

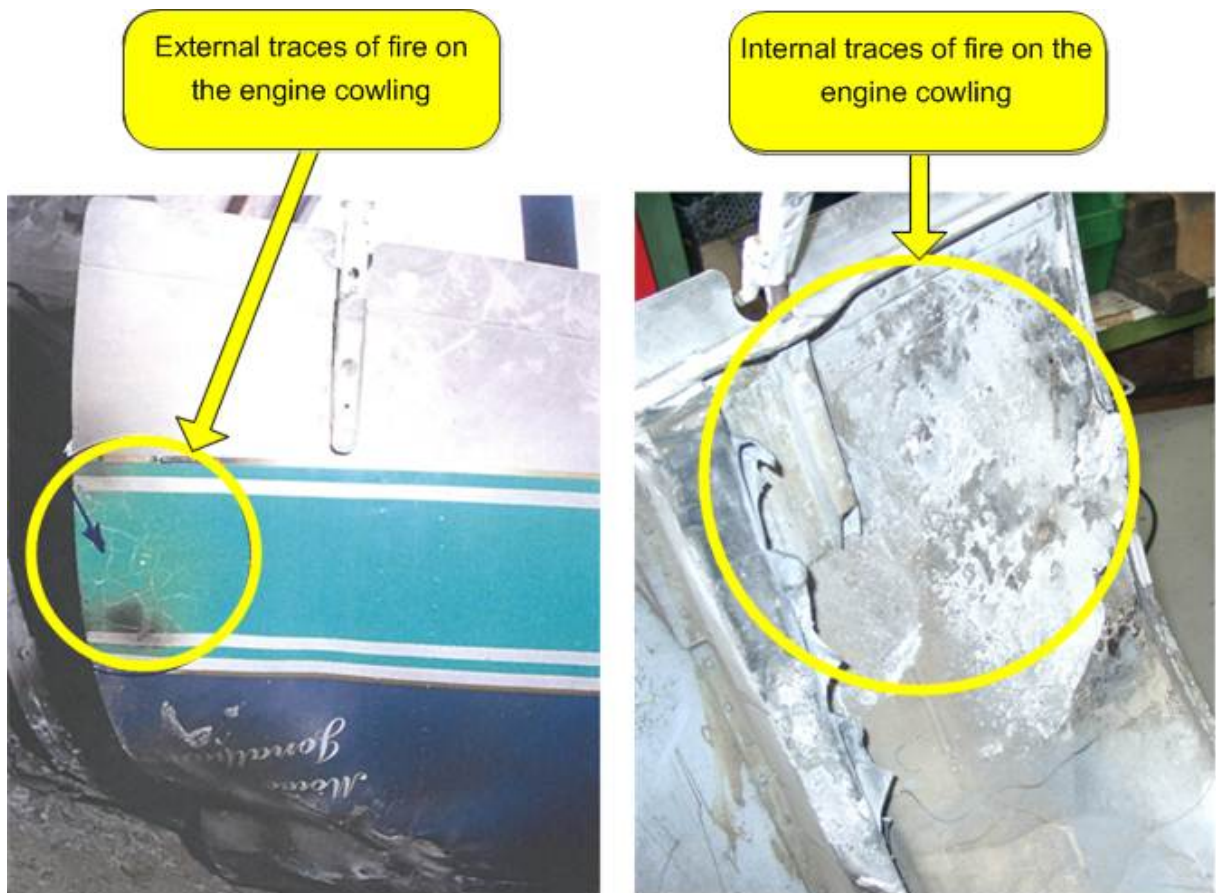
Picture 7 and 8: Traces of fire on the engine cowling

The left outer surface of the engine cowling showed a number of heat-induced changes, but there was no obvious link to other fire damage. The engine cowling right outer surface bore virtually no evidence of heat-induced changes.

While investigating the traces of fire in the wreck on-site, the two engine cowlings were offered up to the inverted engine on the ground. This revealed burn marks on the left side of the lower engine cowling that were clearly different from those found on the upper cowling. The burn marks on the lower cowling could be explained by escaping fuel on impact and the wind direction at that time, but the marks left on the upper cowling did not match the thermal damage of escaping fuel.

On-site inspection of the fire damage to the engine cowling indicated that fire broke out in the vicinity of the carburettor and then spread via the baffle plate to the upper left side of the engine cowling.

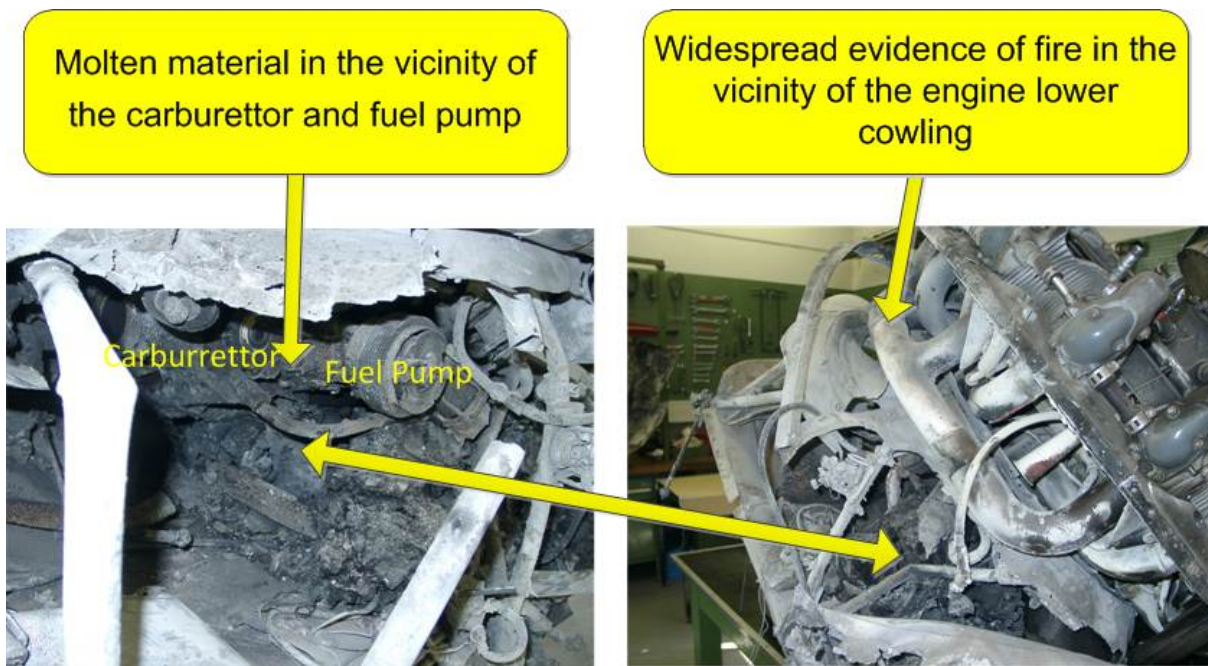
Picture 9 and 10: Evidence of fire in the vicinity of the engine fuel pump

An aluminium baffle plate located between the exhaust pipe support ring and the engine cowling had melted. The carburettor and fuel pump were located behind the baffle plate. These components had areas more than 10 mm thick that had melted away. The carburettor housing had melted away. The carburettor float was exposed.

A carburettor inlet filter with stalactite-like aluminium occlusions was identified at the accident site.

The other fire originated in the fuel supply to the engine and was not associated with the impact fire. The burn marks in the vicinity of the fuel pump and carburettor indicated that the fire spread first under the engine cowling, then outside via the baffle plate. The burn marks can be explained by the fact that there was a mass escape of fuel in the vicinity of the fuel supply that continued to feed the fire under the engine cowling. As seen by the BFU, the fact that aluminium components – which have a melting point of 652°C – broke up, and that parts of the carburettor housing which in part is more than 10 mm thick, were destroyed by fire, is explained by the presence of a major fuel leak in the vicinity of the fuel supply. The burn marks point to an area

between the fuel pump and carburettor. It is suspected that the pump continued to expel fuel through the leak for some time while still in flight.

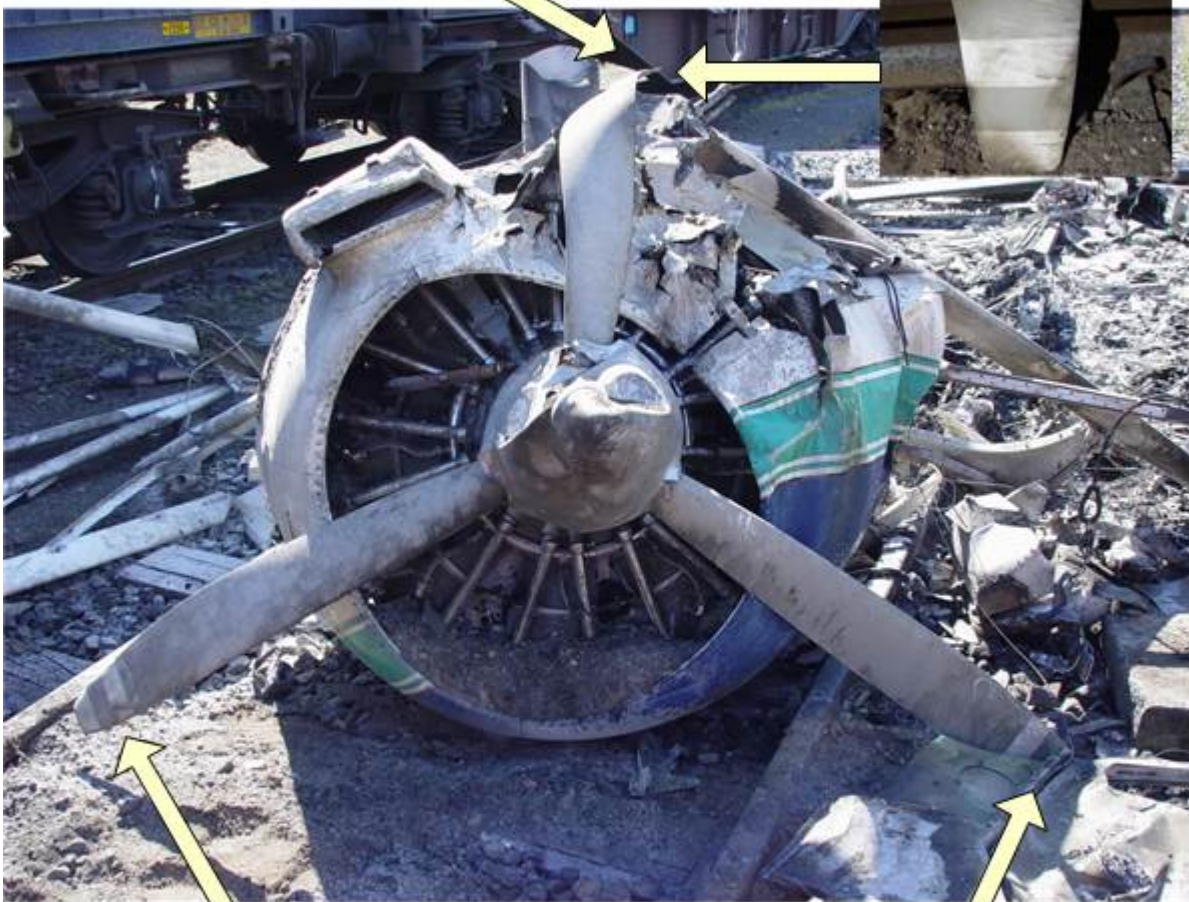
Picture 11: Evaluation of damage to propeller blades

The tip of one propeller blade broke off on contact with a rail track; the damage pattern on this blade indicated that the break was almost entirely due to forward motion. The propeller blade bore no trace of rotary motion. Deformation found on a second propeller blade only bore indication of aircraft forward motion. Since the third propeller blade bore no trace of rotary motion, the inference can be drawn that, at the moment of impact, the engine was delivering either no power at all or only very little power.

Propeller blade bent rearwards; propeller tip broken off; little deformation due to rotary motion.

None or little rotary propeller motion on impact.

Detached propeller tip found embedded in track bed

Propeller blade slightly bent; no deformation arising from rotary motion

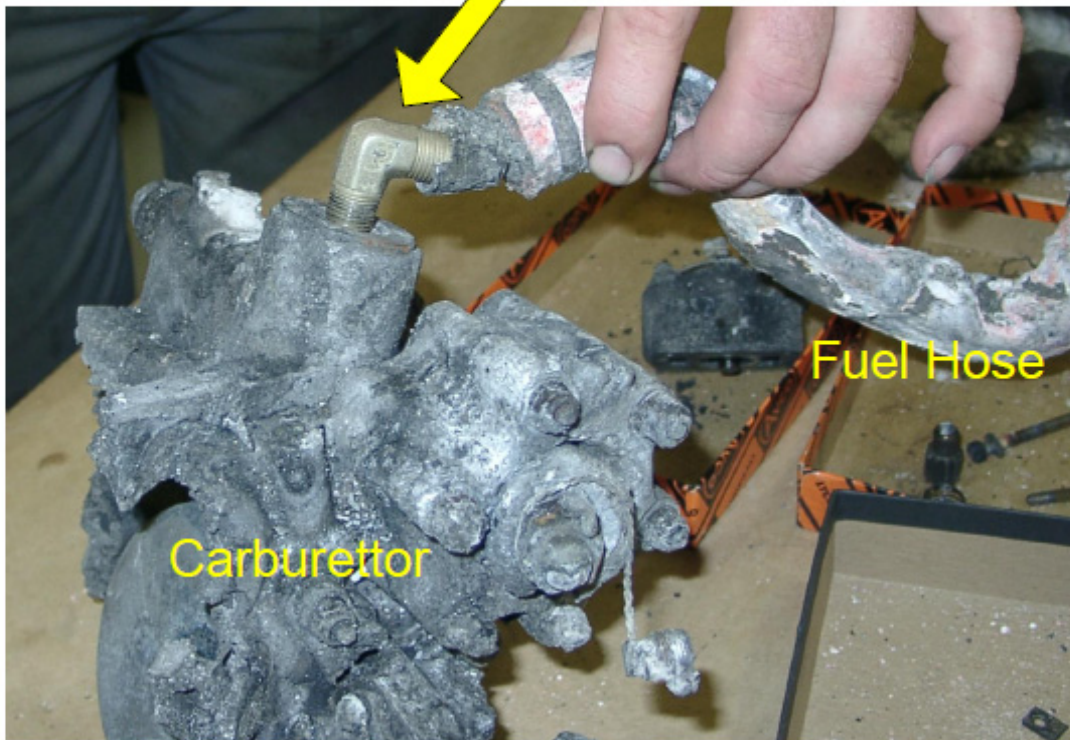
Picture 12: Reconstruction arrangement of the fuel hose to carburettor

The fuel supply hose became detached from the elbow link fitting to the carburettor, because the hose was too short. In support of this proposition, the fuel hose found in the wreck was a few centimetres shorter than that specified by the aircraft manufacturer. However, this cannot be proved beyond reasonable doubt because the hose was damaged and it was not possible to ascertain the actual length with certainty.

The fuel leak originated at or in the elbow link fitting between the fuel hose and carburettor. This might have been due to a material failure or the application of excessive torque during installation. In the opinion of an approved engine maintenance organisation, both possibilities are plausible. It was not possible to prove this proposition one way or the other, because the elbow link fitting was not found in the wreck. It was made of aluminium and probably melted in the fire.

Elbow link fitting between fuel hose and carburettor;  
connector in the photograph is a spare part
