# Investigation Report

Type of Occurrence:	Serious Incident
Date:	6 November 2018
Location:	Clariden, Switzerland
Aircraft:	Transport aircraft
Manufacturer:	Airbus
Type	A340-642
Injuries to Persons:	No injuries
Damage:	None
Other Damage:	None
State File Number:	BFU18-1626-FX

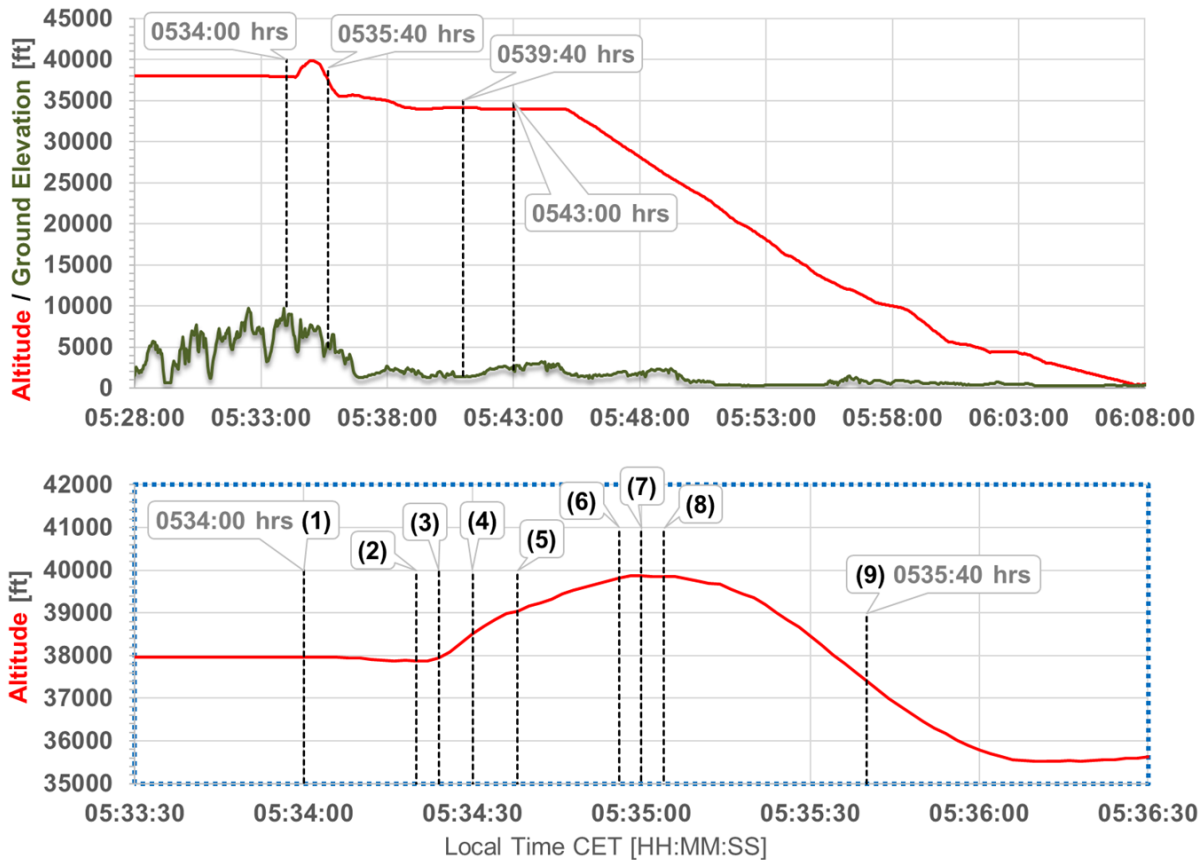
Fig. 1: Vertical course of the flight, with radio communications excerpts, including legend

Nr.	Timestamp	Action
(1)	5:34:00	Wind direction change from 215° to 175°. Wind velocity reduced decreased within 15 s of 50 kt and resulted at the end with 15 kt
(2)	5:34:21	Overspeed Warning (Ma 0,88)
(3)	5:34:25	Autopilot was manually disconnected by the PF
(4)	5:34:30	Engine EPR 0,7 Units and aircraft climbed
(5)	5:34:38	VaProt increased while switching off 2 ADR's
(6)	5:34:57	Call: "Pan Pan Pan"
(7)	5:35:00	At FL400 and CAS decreased to 203 kt (Ma 0,68)
(8)	5:35:03	Stall Warning active
(9)	5:35:40	Call: "Mayday Mayday Mayday"

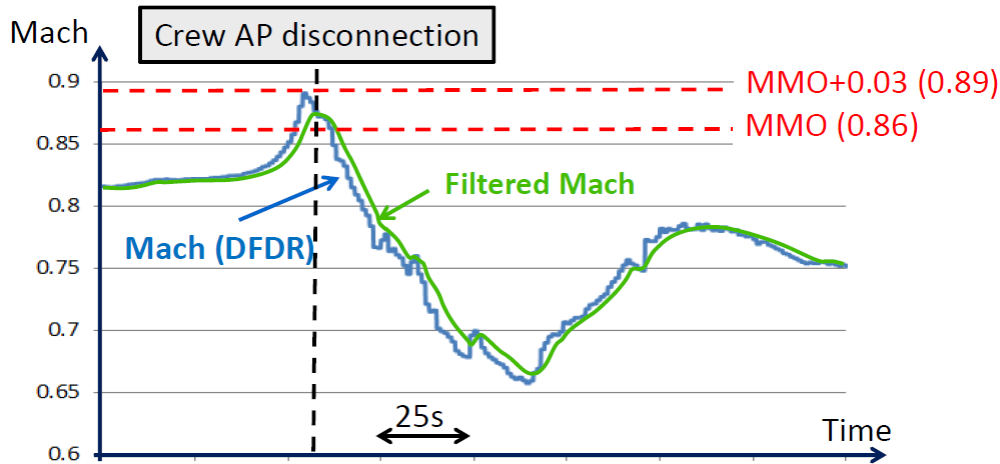
Fig. 6: Filtered Mach function in combination with the FDR data of the occurrence flight

Figure 6 shows the filtered Mach function in combination with the FDR data of the occurrence flight. The time is marked where the PIC disconnected the autopilot.

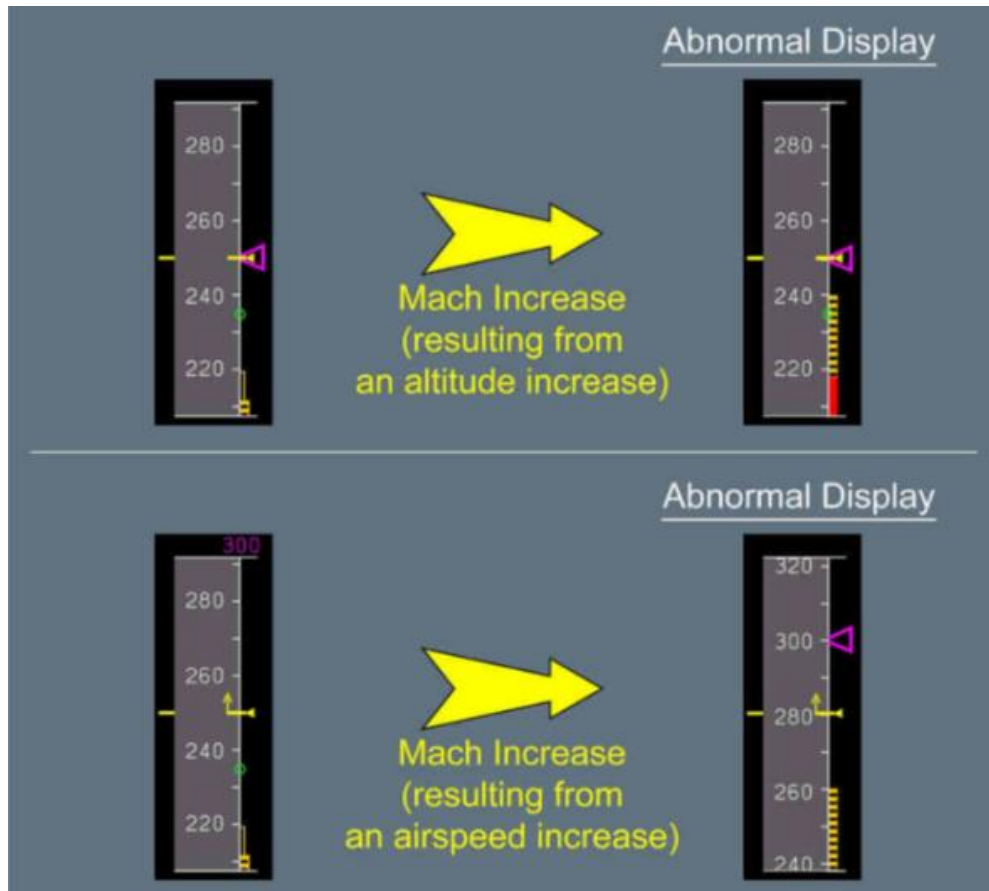
Fig. 15: Abnormal  $V_{\alpha\text{prot}}$  PFD indication

The OEB should be applied preventively if Mach increases due to increasing altitude or airspeed during stabilised straight flight without increase in g-load resulting in a rise of the  $V_{\alpha_{prot}}$  speed band (Fig. 15) so that  $V_{\alpha_{prot}}$  is above the Green Dot. This scenario is the signature of a blockage of multiple AOA sensors that could potentially lead to an unrequested high angle of attack protection activation when reaching a higher Mach. This condition is therefore the Preventive Entry Condition for OEB No. 49.

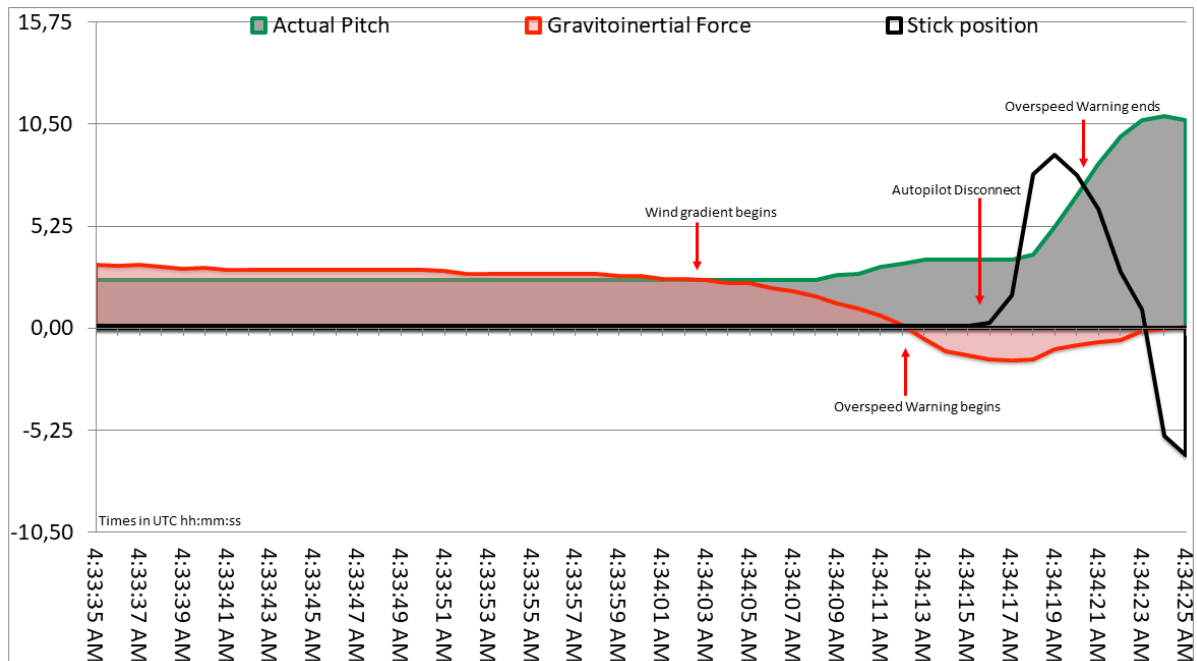
Fig. 21: Gravito-Intertial Force, the actual aircraft pitch angle and sidestick input

The FDR data prove that the fluctuation of wind speed caused by mountain waves and their influence on the aircraft resulted in longitudinal deceleration or acceleration. Using the data of the acceleration sensors, a so-called Gravito-Inertial Force was calculated. It is a force which affects the human equilibrium organ and is experienced by pilots as pitch-up or pitch-down movement.

Analysis showed that the difference between the observed pitch angle, prior to the overspeed condition, and the actual pitch angle was less than  $0.5^\circ$ .

The mountain waves with turning wind directions and decreasing wind speed, caused a longitudinal deceleration of the aircraft. It is very likely that the PIC perceived this as pitch down movement. This effect was possibly a contributing factor for the unnecessarily strong sidestick input which resulted in a high nose up movement.

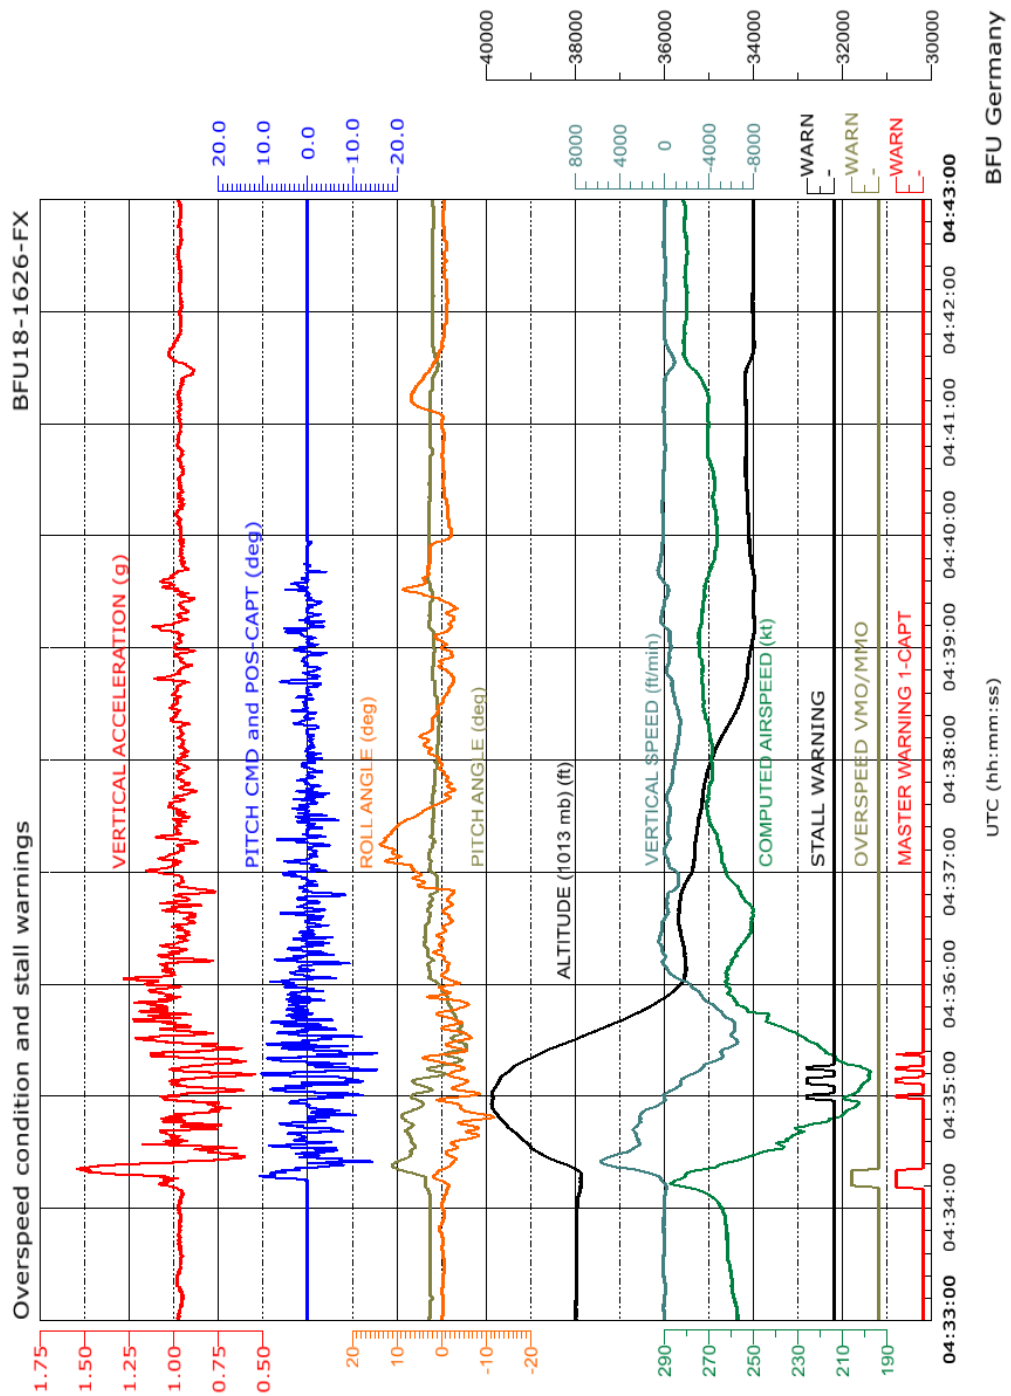
Fig. 22: Overspeed Condition and Stall Warning

Appendix Chapter 5.1 shows an overview of the overspeed condition and the subsequent stall warning.
