Investigation Report

Date: 20 September 2020

Type: Pitts S-1S

State File Number: BFU20-0816-CX

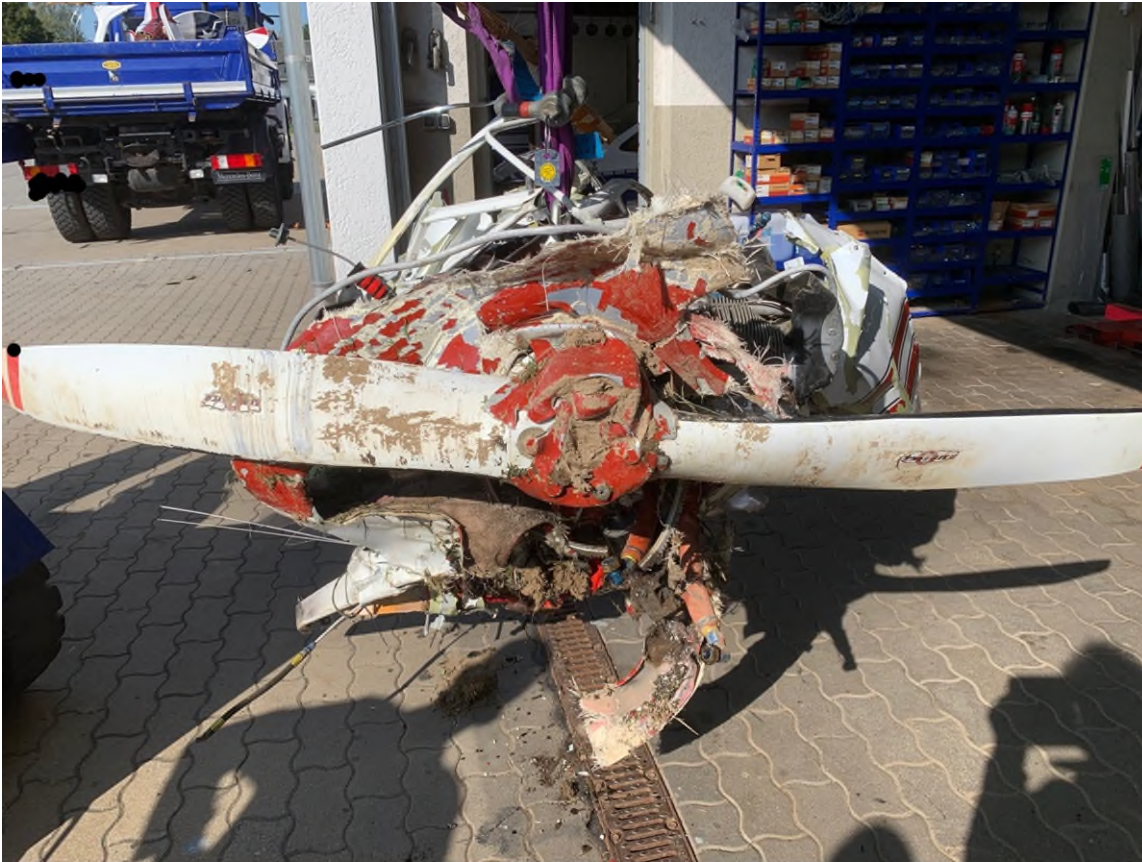
The accident site showed a compact wreckage area. The impact traces show that the airplane had crashed to the ground with a pitch angle of about 70 to 80°. The face of the airspeed indicator showed a mark at about 150 mph.

The propeller blades were bent backwards and showed no spiral twisting (Fig. 1).

Fig. 1: Wreckage after salvation
