Investigation Report

Location: TRA Lauter (ED-R205)

State File Number: BFU21-0957-RX

In the Temporary Reserved Airspace (TRA) Lauter (ED-R205), an airprox occurred involving a PA-200 (VFR) and a SR 22 (IFR). The closest lateral distance was 0.4 NM and the vertical 200 ft.

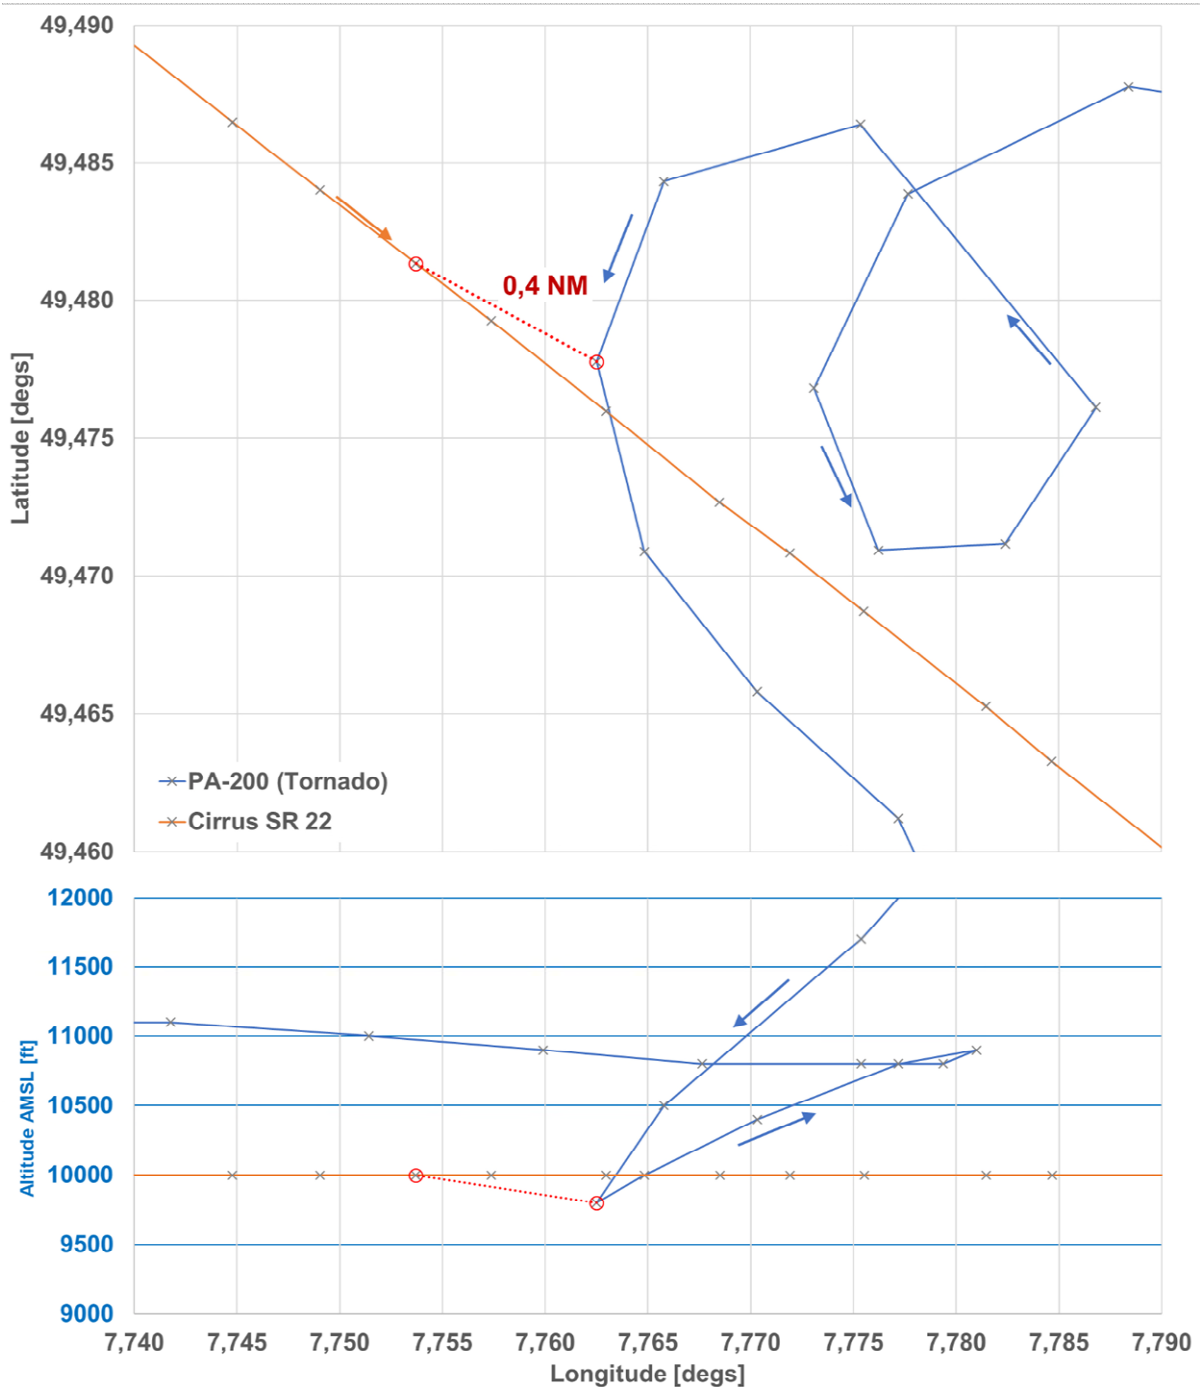
Fig. 1: Flight paths

The SR 22 crossed the TRA in south-eastern direction at FL 100. The two PA-200 used the TRA for air combat exercises between FL 100 and FL 240. In the process, an airprox occurred involving one of the two PA-200 and the SR 22. The closest lateral distance was 0.4 NM and the vertical 200 ft.

The flight crew did not properly acknowledge that the CRC raised the lowest usable flight level to FL 120. However, at that time the airprox had already occurred. Therefore, it is irrelevant whether the PIC had observed this instruction and implemented it. However, the PA-200 infringed the previously stipulated lowest usable flight level of FL 110. This resulted in the airprox with the SR 22.
