# Investigation Report

Type of Occurrence: Serious Incident

Date: 23 May 2022

Type: Citation 560XLS +

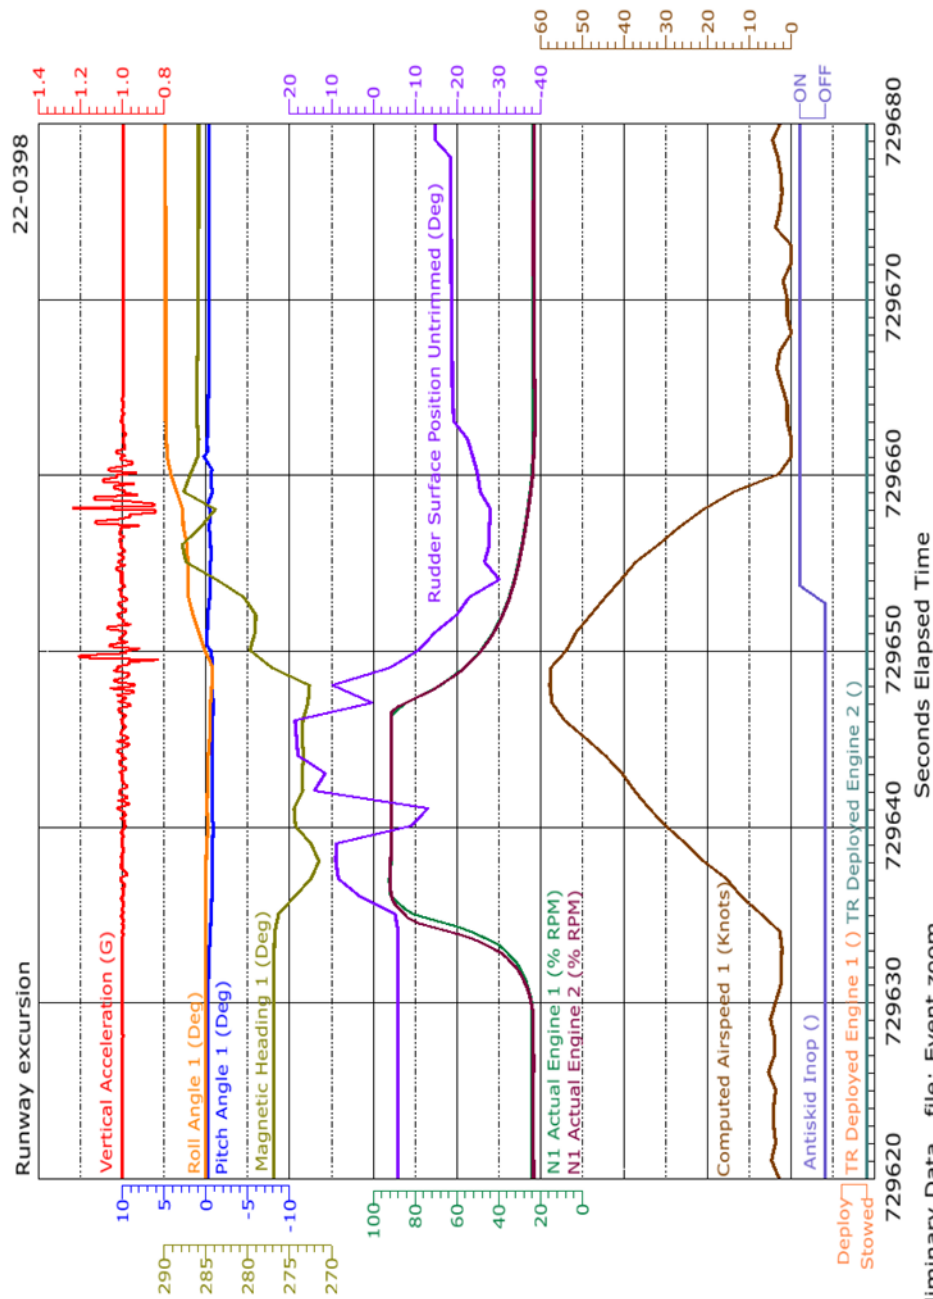
Fig. 1: FDR recordings

According to the FDR recording, which was read out at the BFU, the flight crew aborted take-off at a speed of about 59 kt (Fig. 1). According to the CVR (1380:52 hrs: „*Die Bremse ist angezogen!* (The brake is engaged)”), the parking brake had not been released.

The brown line in Figure 1 (Computed Airspeed 1 (Knots)) shows the course of the speed. The graph shows that until the rejected take-off a maximum speed of about 59 kt was reached.

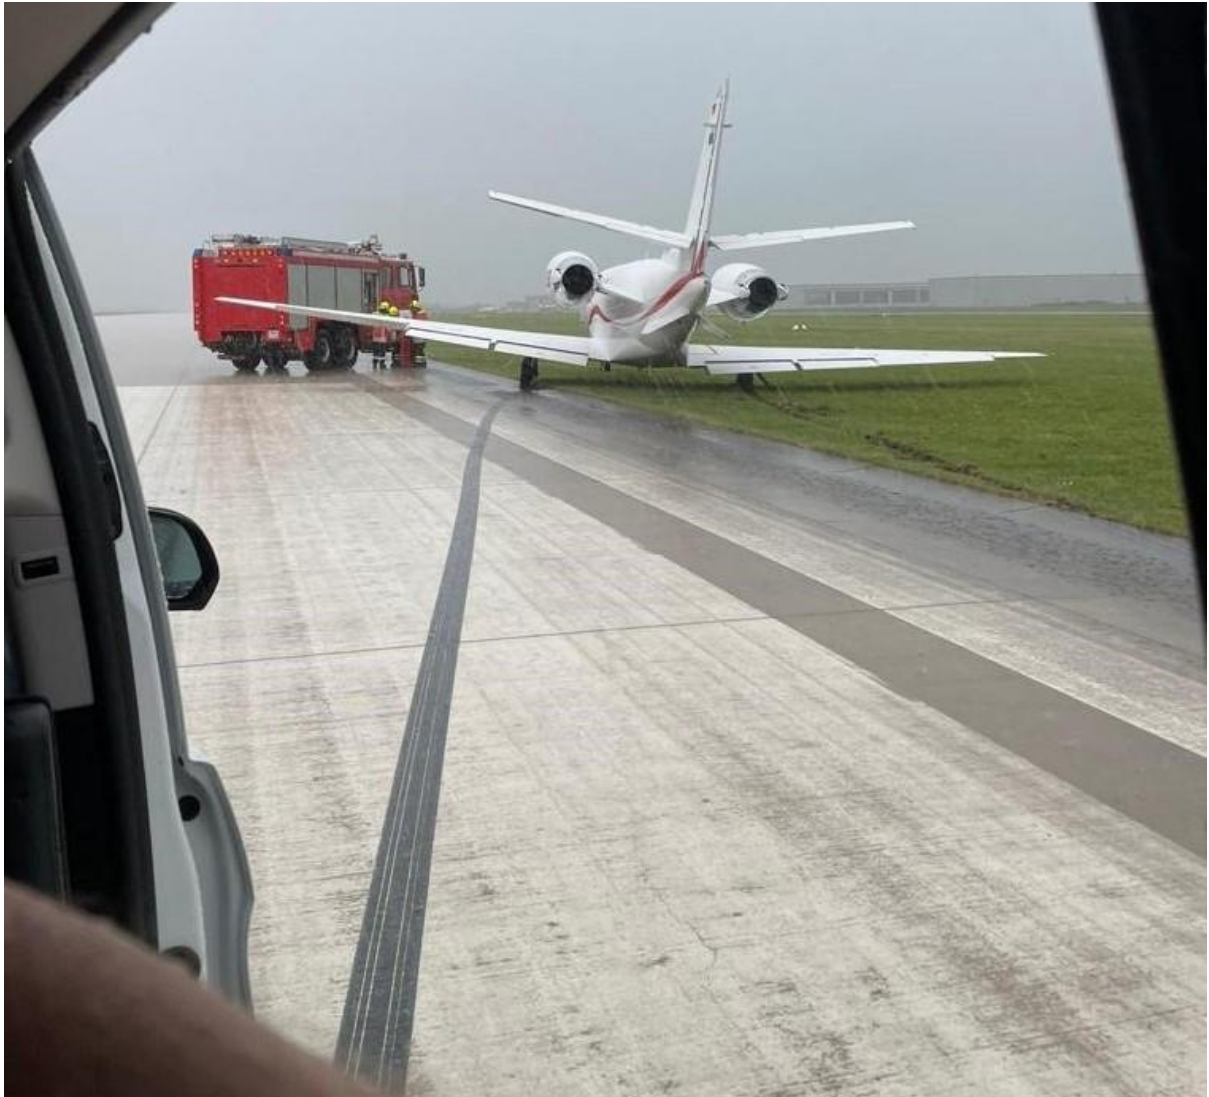
Fig. 2: Final position of the aircraft

The aircraft came to a stop on runway 28 in the area of the touch down zone of the glide path of ILS runway 28. The airplane's left main landing gear was on the runway, the nose landing gear and the right main landing gear were in the grass to the right of the runway. The right main landing gear tire was destroyed. The rubber abrasion marks of the left main landing gear tire are clearly visible in Figure 2. Parts of the right tire were found on the runway.

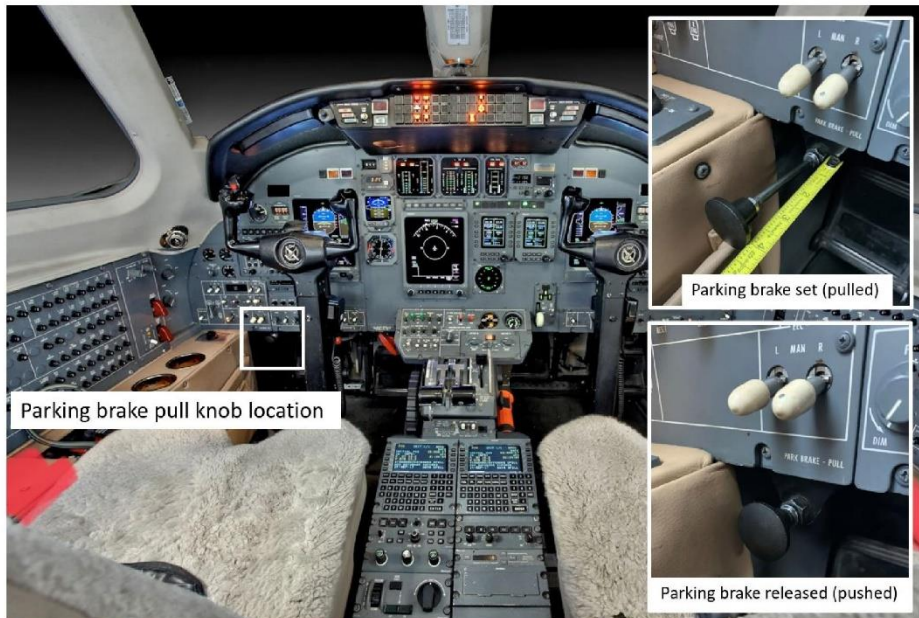
**Figure 1.** The location of the parking brake pull knob in a Cessna 560XL exemplar airplane (XLS model). (Source: Delta Private Jets)

Only the left-seat pilot of a Cessna 560XL may set the parking brake at various points before takeoff, such as when holding short of the runway, before receiving clearance to take off, or before initiating takeoff. For example, the pilot flying (who was in the left seat of the Oroville accident airplane) recalled that he likely set the parking brake while holding short of the runway as he finished the items in the taxi checklist.<sup>7</sup> To set the parking brake in a Cessna 560XL airplane, the left-seat pilot depresses the toe brakes while pulling the parking brake pull knob, which is shown in the figure below. The amount of wheel brake pressure applied depends on how fully the toe brakes are depressed when the parking brake pull knob is pulled. To release the parking brake pressure, the left-seat pilot pushes the parking brake pull knob forward. Given the Cessna 560XL parking brake pull knob’s location on the lower left side of the left-seat pilot near that pilot’s knee, the pull knob is not visible to the right-seat pilot.
