Bundesstelle für Flugunfalluntersuchung

Investigation Report

Type of Occurrence:	Serious Incident
Date:	21 June 2022
Location:	Westerland/Sylt
Aircraft:	Airplane
Manufacturer:	Cessna Aircraft Company
Туре:	525 A
Injuries to persons:	None
Damage:	Aircraft not damaged
Other Damage:	None

State File Number: BFU22-0564-5X

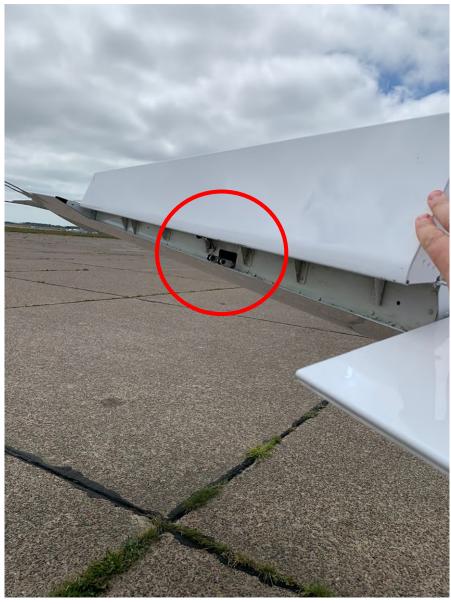
During climb, aileron fluttering occurred. The airplane returned to the aerodrome of departure and landed without further incident. After landing, it was determined that at the left aileron the trim tab was not hinged.

The serious incident occurred on departure from Sylt Airport. The post-flight inspection showed that the link to the aileron trim tab was missing (Fig. 1).

Fig. 1: Missing link to the aileron trim tab

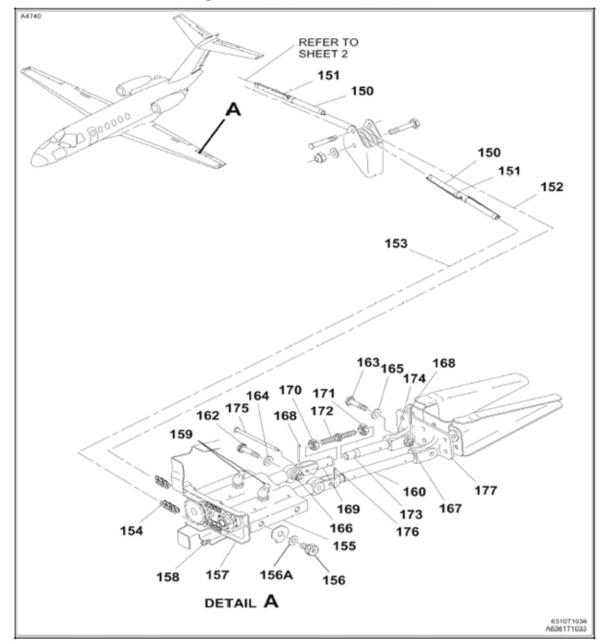
Figure 01 : Sheet 03 : AILERON TRIM CONTROL SYSTEM

The link between control and aileron trim tab consisted of two pushrods (Fig. 2, part number 160). Each of their clevises are bolted and secured to the trimming tab by a bolt (Fig. 2, part number 163) with washer (Fig. 2, part number 165) and a crown nut (Fig. 2, part number 167) with cotter pin (Fig. 2, part number 168). These components of the two screwings were missing and could not be found.

Fig. 2: Aileron trim control system
