# Investigation Report

Type of Occurrence: Accident

Date: 11 July 2020

State File Number: BFU20-0502-CX

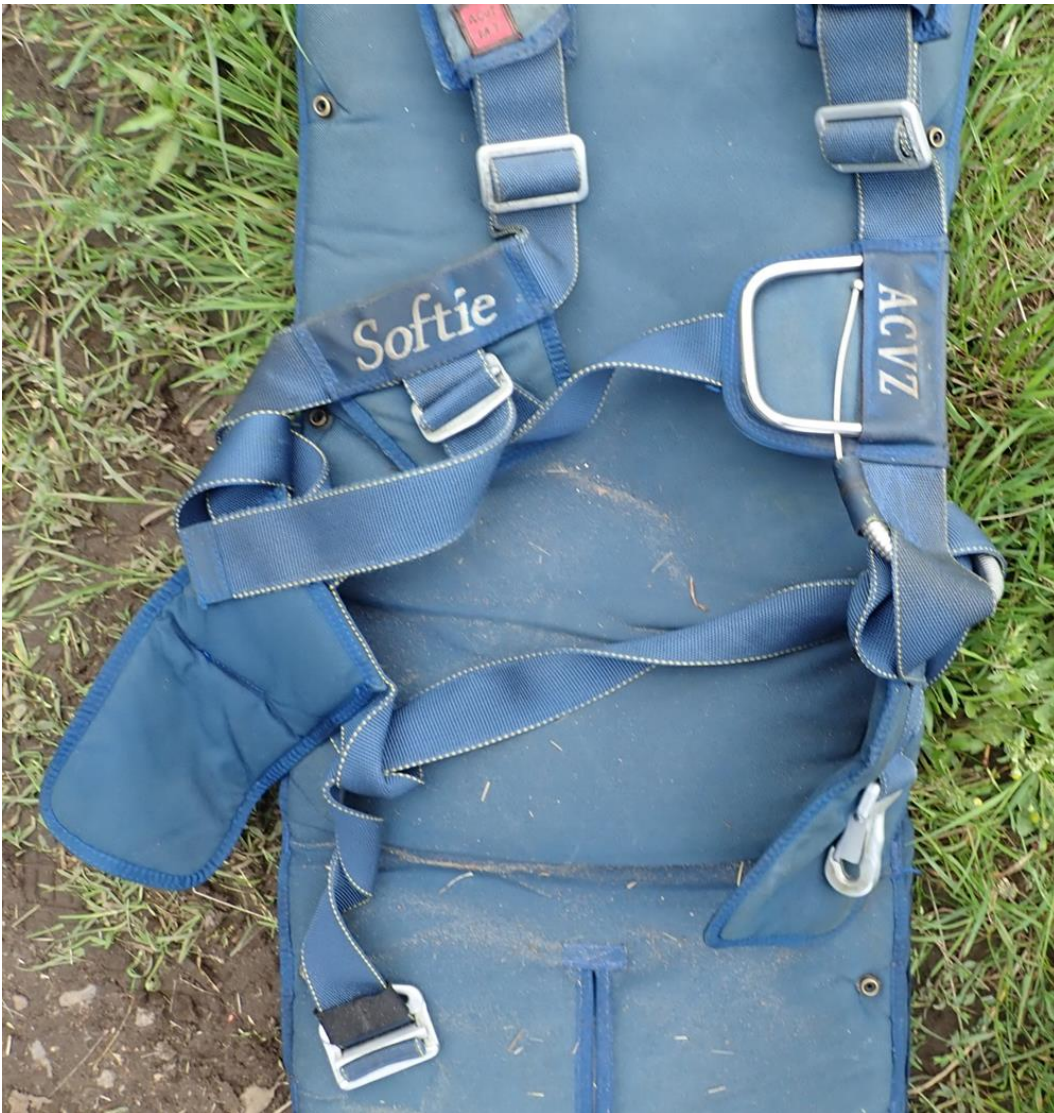
Fig. 4: Emergency parachute with open leg harness

The emergency parachute was found with the leg harness open (Fig. 4).

The LS4-b pilot was found without a parachute outside the wreckage. The harness of the emergency parachute was found with an open leg harness, i. e. it was not closed and separated in freefall. The emergency parachute was complete and did not show any signs of having been triggered.

Pilot and emergency parachute were found outside the wreckage. The spatial separation of pilot, emergency parachute and glider wreckage indicate leaving the cockpit shortly after the collision. It is highly likely that the pilot had slipped out of the harness shortly after leaving the cockpit. Since the parachute's activation handle had not been activated this must have happened immediately after leaving the glider.

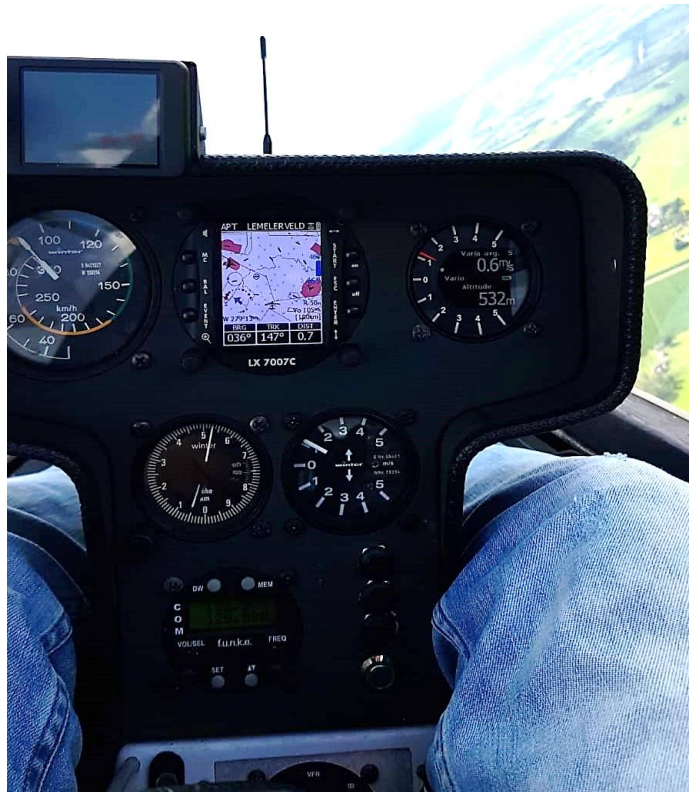
Fig. 5: Cockpit of the DG-300 with FLARM indication and navigation computer (top centre)

The operator stated that a FLARM firmware update had failed because the accident pilot (as joint operator) had downloaded an incompatible version for the LX 7007C. The system had shown a corresponding indication.

Due to a missing update, the FLARM of the DG-300 was not functional. With proper use, FLARM provides useful assistance for collision avoidance. Warning the pilot of possible collisions is its function. This only works if both gliders involved in a possible conflict situation are equipped with a functioning system. Because FLARM devices are not installed in all gliders, there is a probability that warning is not given about all the aircraft flying in the vicinity.

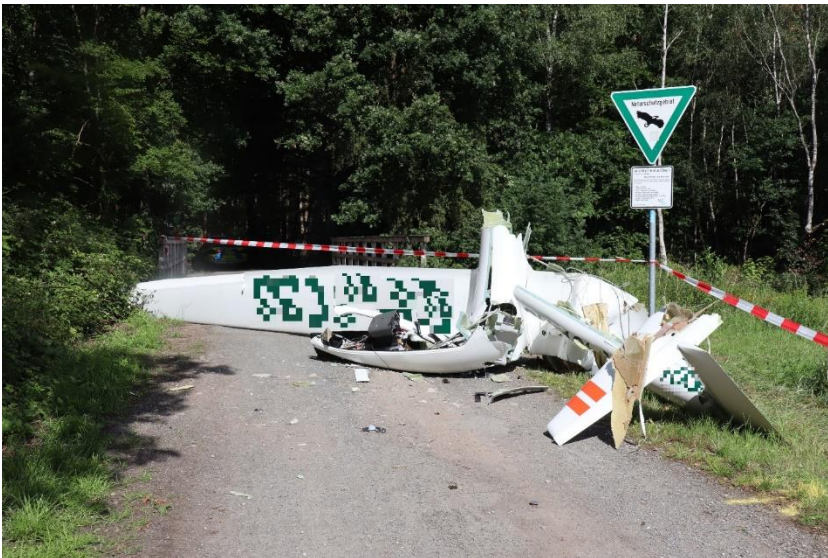
Fig. 7: Accident site DG-300

The wreckage of the DG-300 was lying on a road about 128 m north-east of the LS4-b lying in a forest (Fig. 7 and 8).

The cabin area was destroyed. The canopy was lying about 250 m east of the wreckage on the roof of a farm. The canopy's latch was closed. On the fuselage side, the canopy's hinge had been bent up on the mounting bolts.

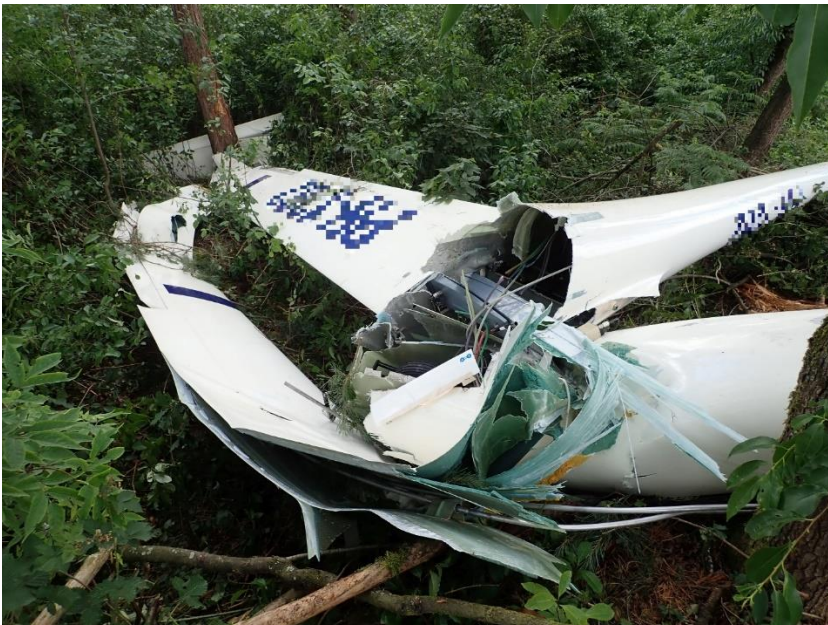
Fig. 8: Accident site LS4-b in the forest

The LS4-b was lying inverted between trees on the ground. The fuselage had fractured behind the cockpit and prior to the tail boom. The elevator had fractured. The right wing had fractured at the spar and been severed from the fuselage. Both wings were connected in the spar bridge.

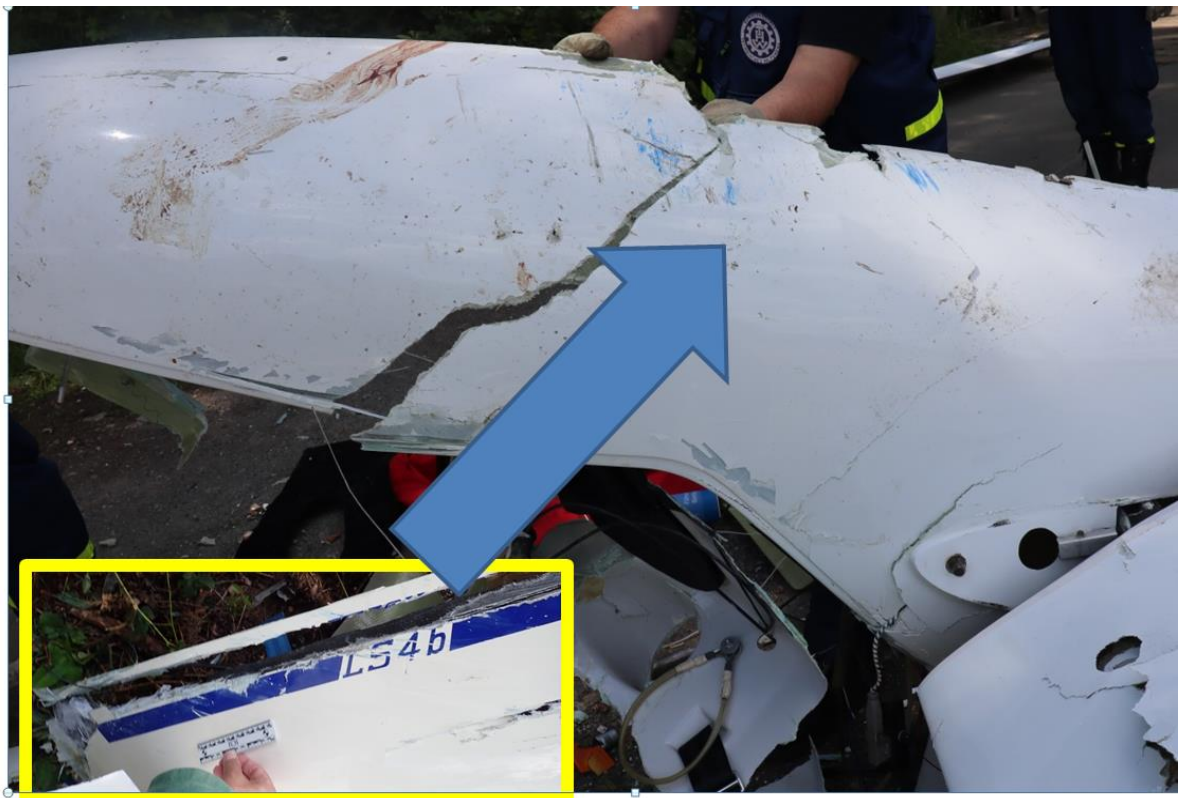
Fig. 9: Collision traces at the DG-300 fuselage and the LS4-b

Fuselage and left wing had fractured in several places. The elevator had fractured. The fuselage's lower surface, in the area of the wheel well and the cockpit, showed traces of the collision. Blue and red paint transfer marks, which could be assigned to the LS4-b, were found in the landing gear area (Fig. 9). The lower surface of the fractured right wing showed paint transfer marks which corresponded with the elevator of the LS4-b.

Paint abrasions of the blue type lettering at the left fuselage side of the LS4-b corresponded with the paint transfer marks on the lower fuselage of the DG-300 (Fig. 9). The red paint transfer marks on the DG-300 corresponded with the paint abrasions on the canopy lock of the LS4-b. The leading edge of the right elevator of the LS4-b showed green paint transfer marks which corresponded with the damage on the right wing of the DG-300. The left wing showed paint transfer marks of the DG-300's elevator (Fig. 11).

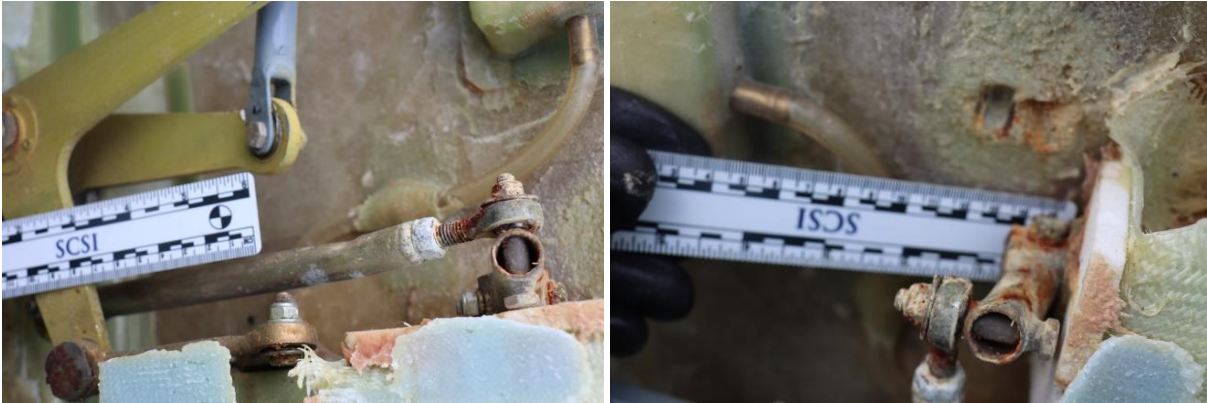
Fig. 10: Corrosion on the control rods and the bearing blocks in the wing of the DG-300

The technical examination of the wreckage on site determined that the control rods and bearing blocks in the wings were corroded (Fig. 10).

The corrosion of the control rods and bearing blocks in the wings of the DG-300 did not result in an impairment of the controls.
