# Investigation Report

Location: Kassel-Calden

Type: Meridian

State File Number: BFU23-0705-3X

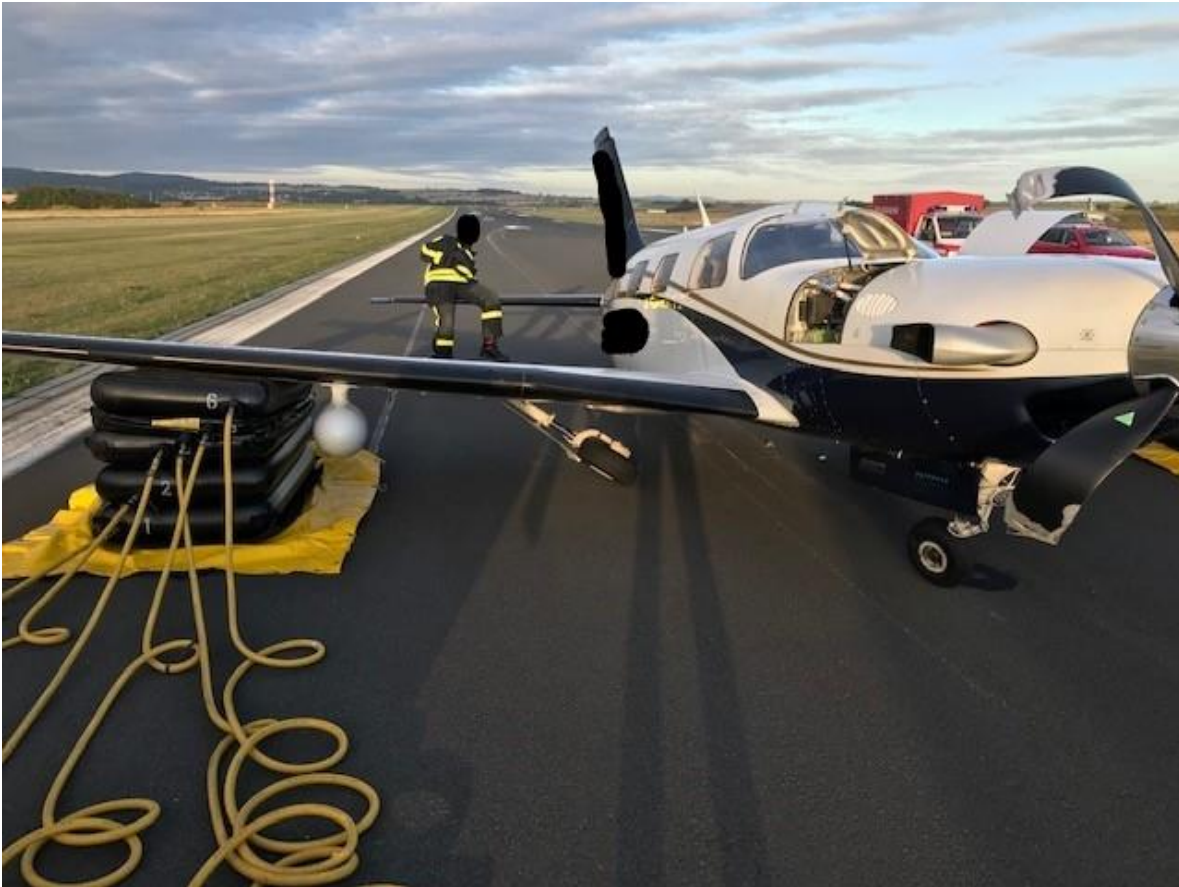
During the landing, the aircraft touched down with the landing gear retracted and was substantially damaged.

The accident site was located on runway 27 of Kassel-Calden Airport and abeam of the Tower. Continuous skid marks were found on the runway. Propeller and aircraft underside (pressurized cabin) were substantially damaged.

Fig. 1: Aircraft during the salvage operation
