Interim Report

Type of Occurrence: Accident

Date: 4 September 2022

Type: Cessna 551, Citation II

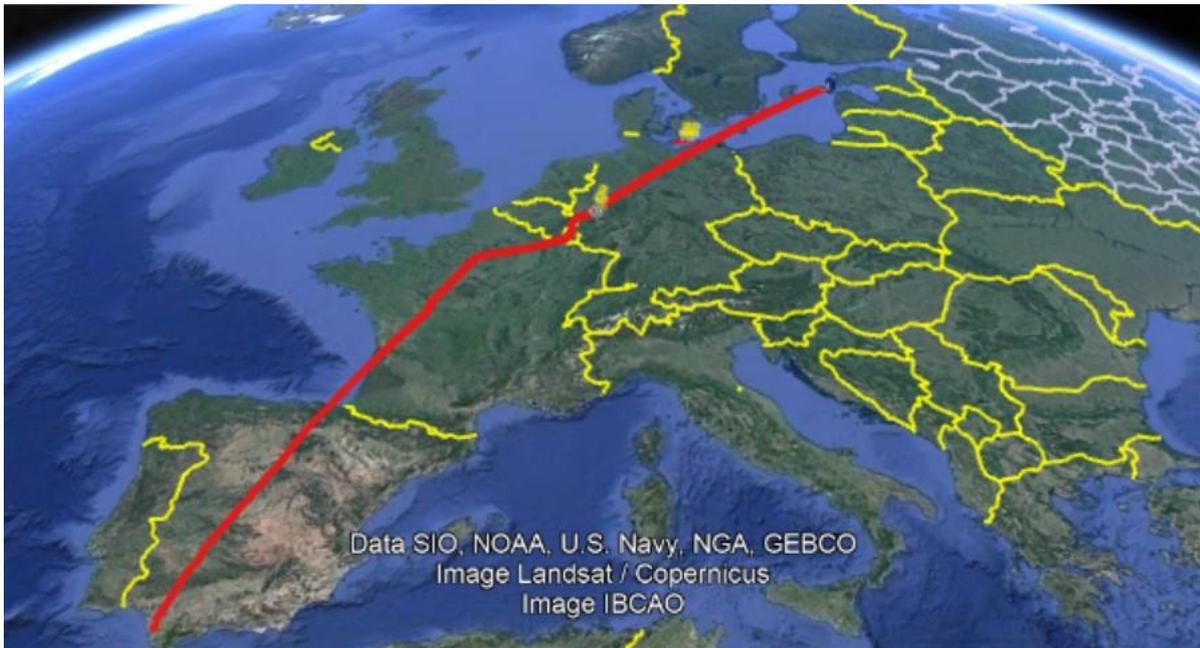
Fig. 1: Overview over the entire flight from take-off to impact

At 1736 UTC, while descending through FL 275, the airplane turned right towards east. At 1740 UTC, passing FL 200, the airplane turned left, entered a spiral and at 1745 UTC (2045 local time), crashed into the Baltic Sea.

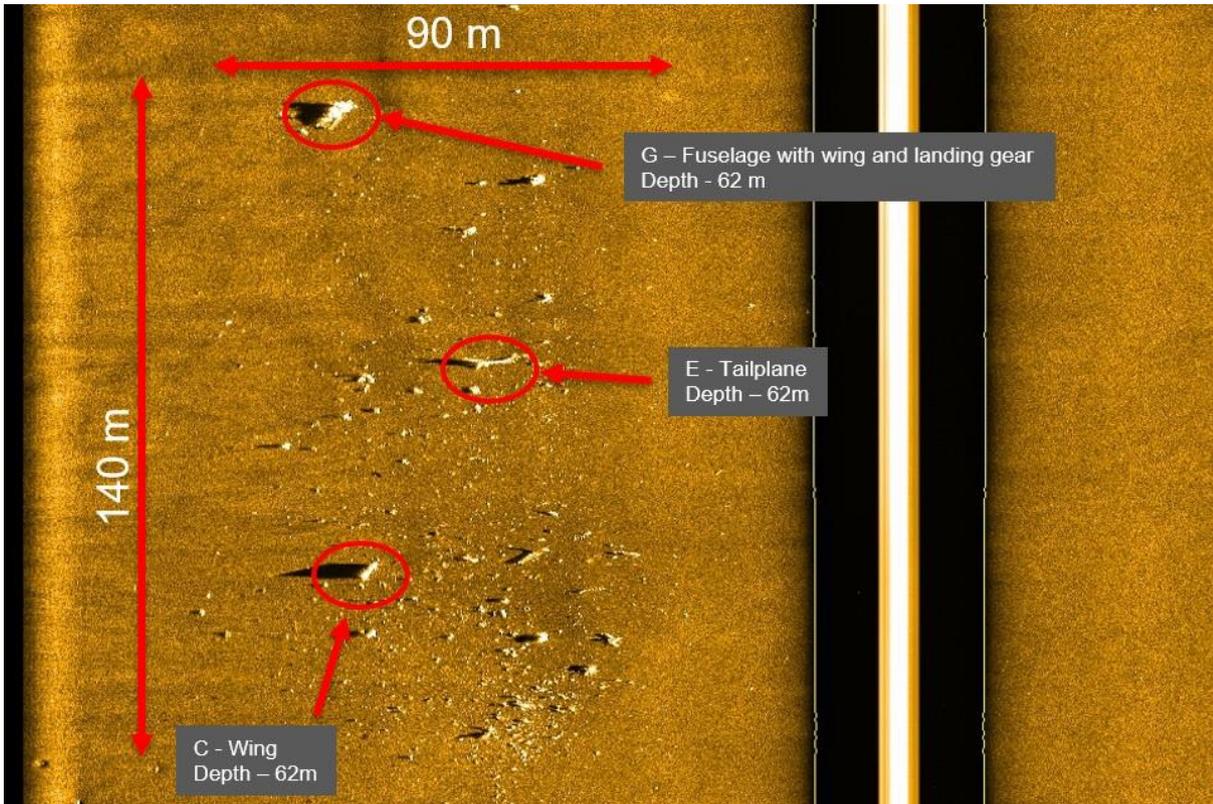
On impact with the surface of the water, the airplane had been destroyed. Besides the numerous smaller wreckage parts, three larger ones were found: one piece of the fuselage including parts of the wing and landing gear, another piece of wing and parts of the tail (Fig. 14 and 15).

Fig. 14: Degree of destruction and distribution of wreckage parts on the sea bottom

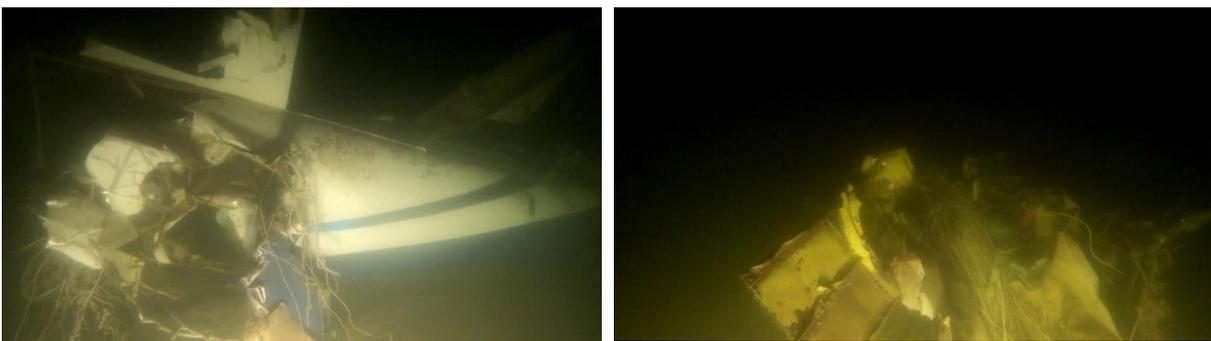
Fig. 15: Tail (left), fuselage (right)
