Interim Report

Type of Occurrence:	Accident
Date:	31 March 2019
Location:	near Egelsbach
Aircraft:	Airplane
Manufacturer / Model:	Experimental Amateur built / EPIC LT
Injuries to Persons:	Pilot and 2 passengers fatally injured
Damage:	Aircraft destroyed
Other Damage:	Crop damage
State File Number:	BFU19-0272-CX
Date of Publication	May 2019

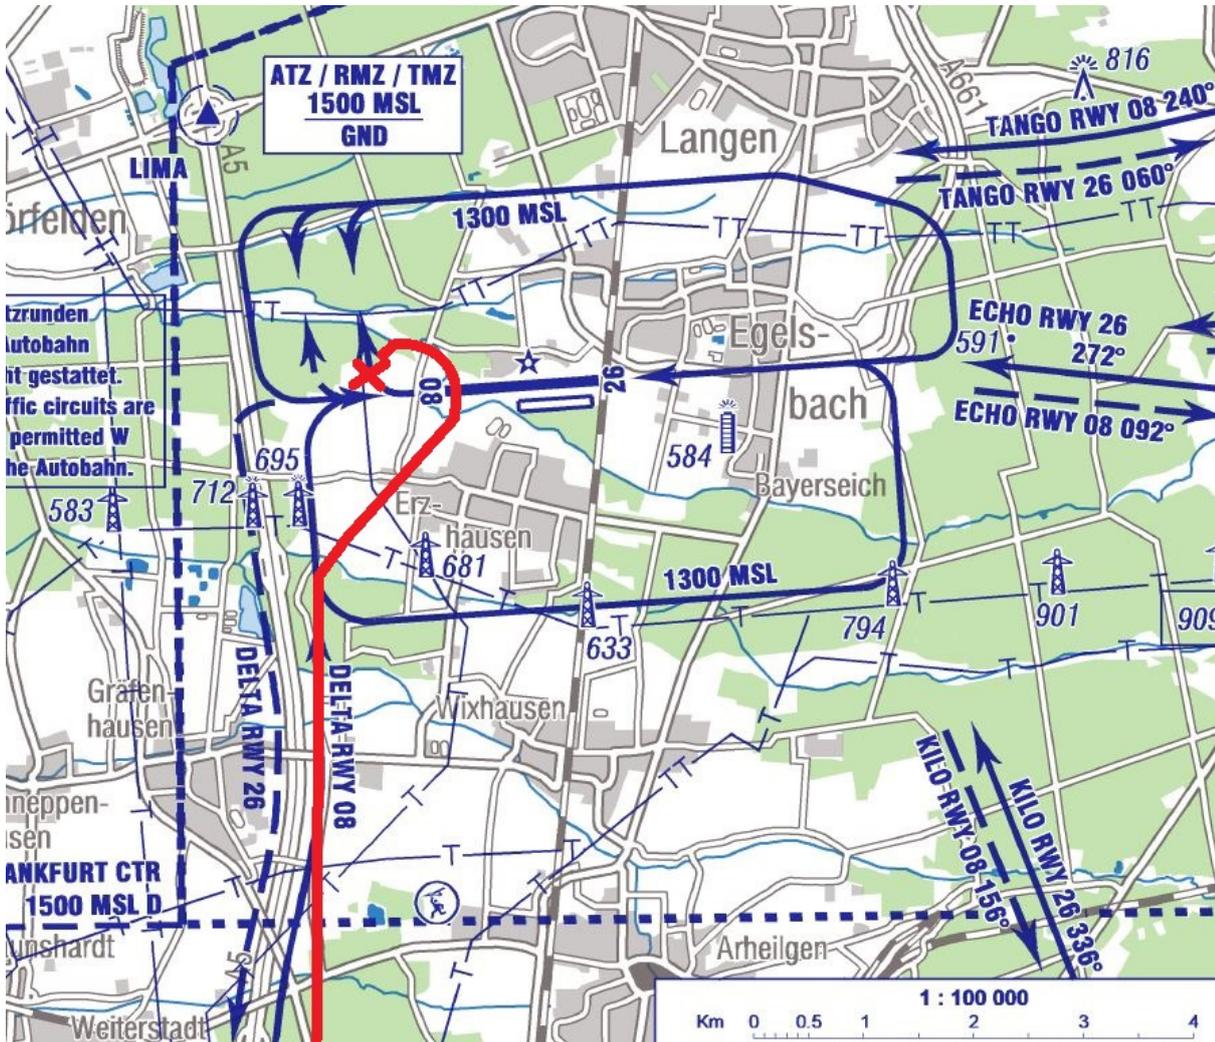
At 1527:11 hrs, the airplane crossed runway 08 with a ground speed of about 100 kt at very low altitude with northern heading.

At 1527:31 hrs, the last radar target was recorded at approximately 600 m north-west of threshold 08 indicating an altitude of about 425 ft AMSL. About 100 m south-west of it the airplane crashed to the ground and caught fire. All three occupants suffered fatal injuries.

Fig. 2: Flight path of the aircraft and accident site: Excerpt of the visual approach chart of Frankfurt-Egelsbach Airfield with flight path of the aircraft (red line) and the accident site (red cross). Source: AIP/Adaptation: BFU

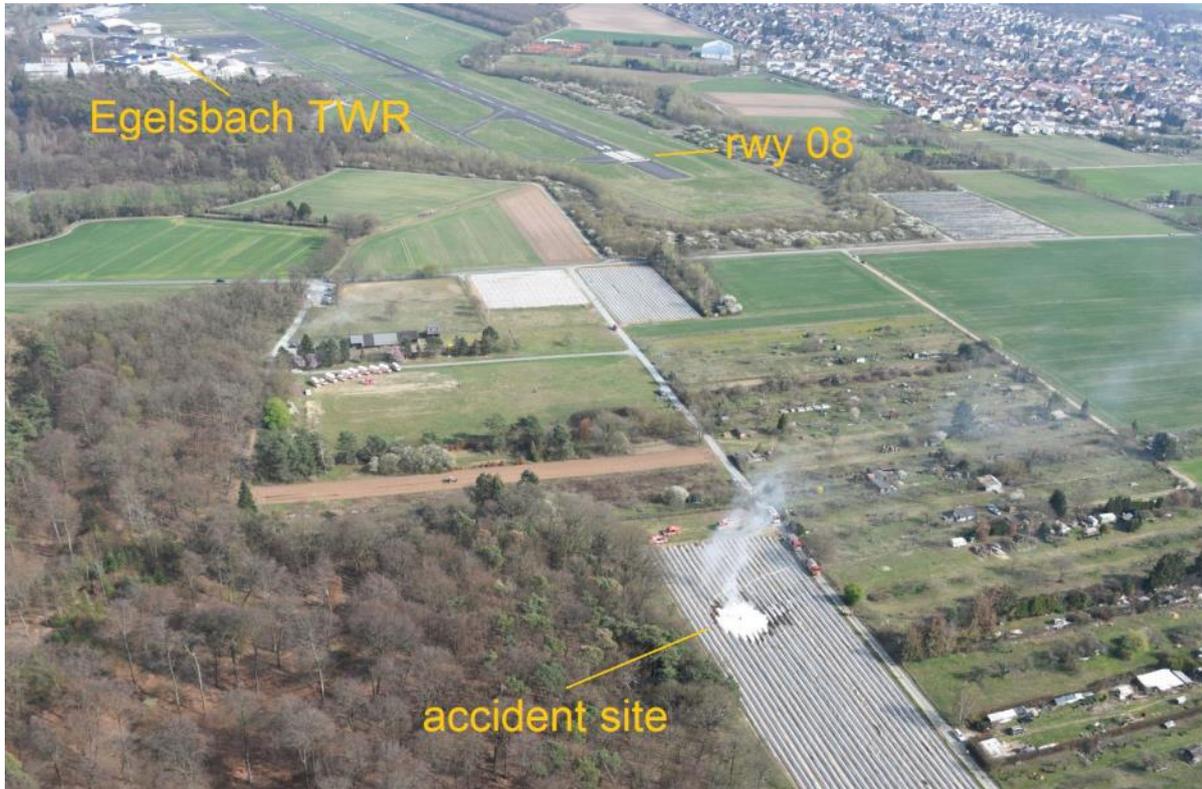
The accident site was located about 600 m north-west of threshold 08 and about 300 m north of the extended runway centre line, at a flat asparagus patch, which was partially covered with plastic.

The plastic had either burnt or melted in an almost circular area with a radius of about 20 m around the wreckage.

Fig. 3: Location of the accident site in relation to the airfield; viewed toward south-east

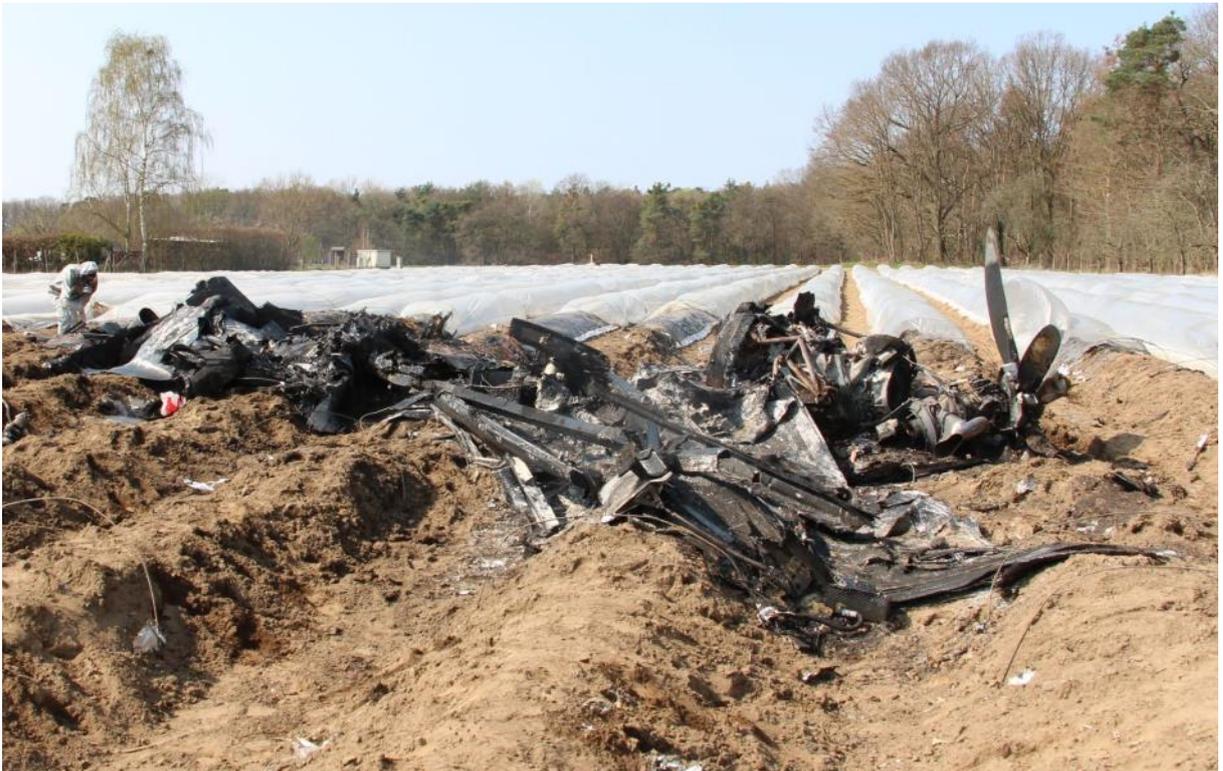
The traces at the accident site and the damages on the aircraft showed that the airplane had impacted the ground with an almost vertical flight path with nose down attitude and slight left bank angle. The fuselage nose including the spinner of the propeller pointed toward approximately 020°.

The entire fuselage and wing unit had been destroyed by fire. The form of the aft part of the fuselage, between trailing edge of the wings and the empennage, was intact, but the structure had been destroyed by fire. The front part of the fuselage including cockpit had been destroyed by fire except for the floor component. The cockpit displays (PFD and MFD) including SD-cards had been destroyed by fire.

The wings had separated from the fuselage and were lying about 25° turned left about the vertical axis. On the right wing the flap was folded beneath the wing spar. The weather radar had been torn off the right wing and was lying about 5 m north of the wreckage. The landing gear had been extended.

Fig. 4: Overview of the wreckage, viewed toward west

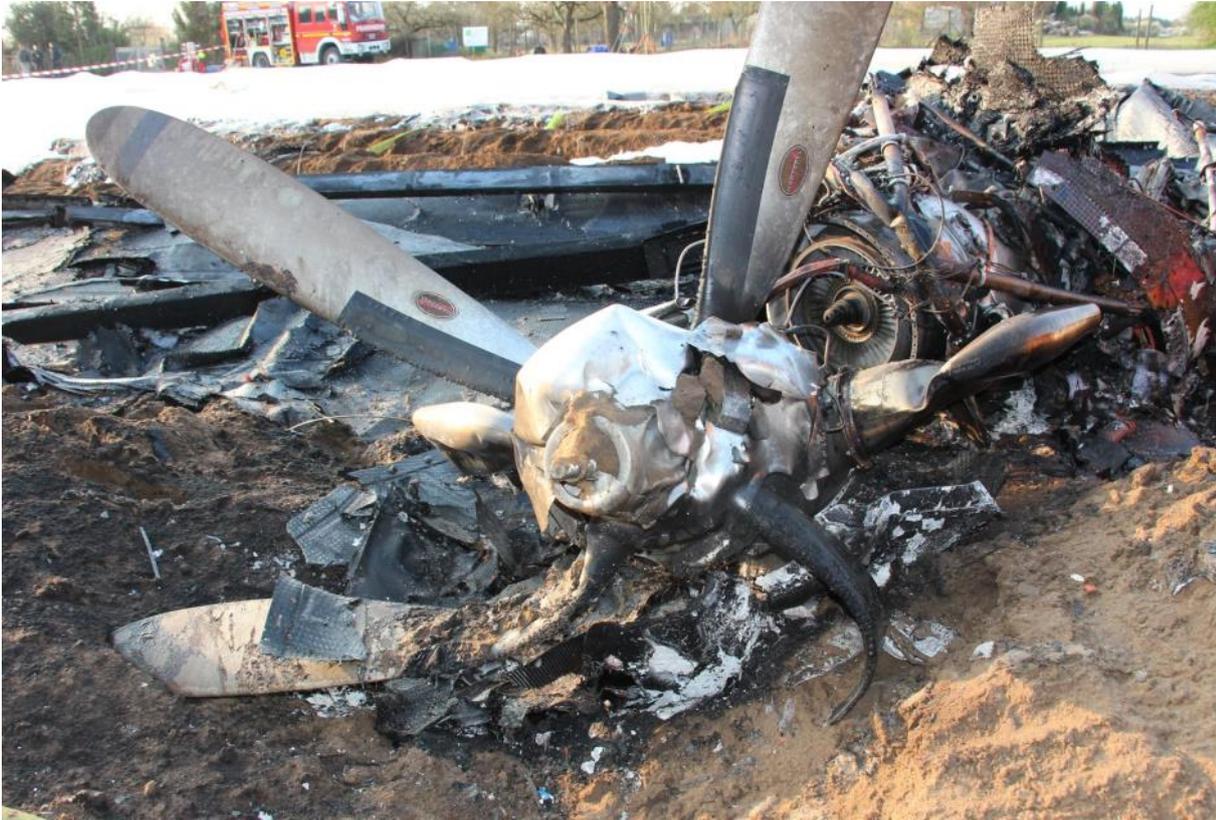
Fig. 5: Damages on the propeller blades and the spinner

Two of the four propellers blades were deformed contrary to their rotating direction. The examination of the engine with a Boroscope showed ingested earth and soot in the area of the first stage compressor rotor.
