Interim Report

Type of Occurrence:	Serious incident
Date:	8 October 2019
Location:	Münster/Osnabrück Airport
Aircraft:	Airplane
Manufacturer / Model:	BAe Systems / Jetstream 32
Injuries to Persons:	No injuries
Damage:	Minor damage to aircraft
Other Damage:	One runway edge light and an information sign damaged, crop damage
State File Number:	BFU19-1422-EX
Date of Publication	December 2019

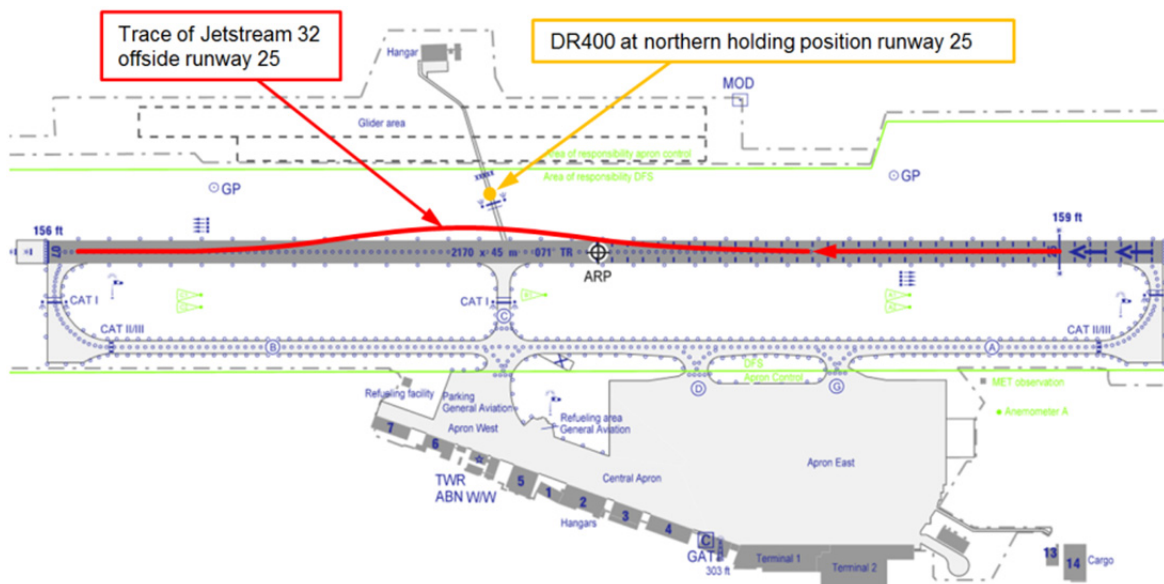
During the aborted take-off the aircraft veered north off the runway after about 1,080 m (Fig. 2). One runway edge light and an information sign (for the glider area) were damaged in the process. The aircraft crossed the northern taxiway (connection with the flying club) of runway 25. The maximum distance to the runway edge was 23 m. After about 530 m on unpaved ground the aircraft returned to the runway.

Fig. 2: Trace of the aborted take-off on runway 25

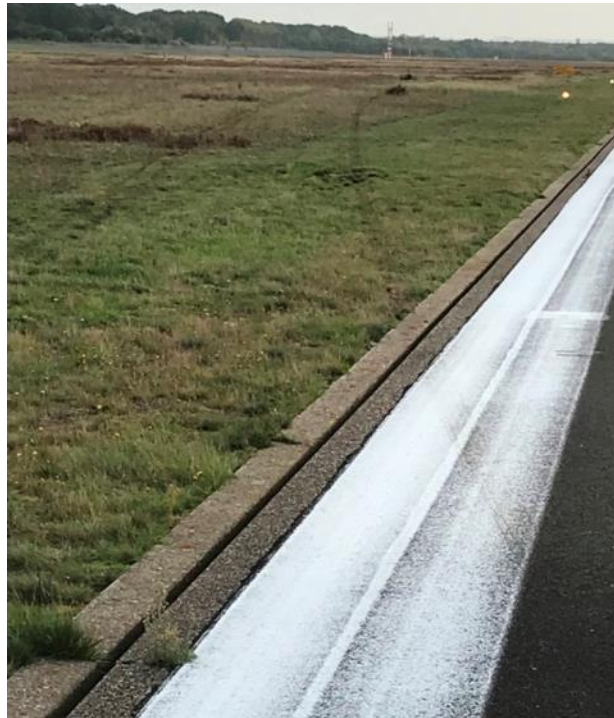
Fig. 3: The end of the traces next to runway 25 (view direction 070°) Source: BFU

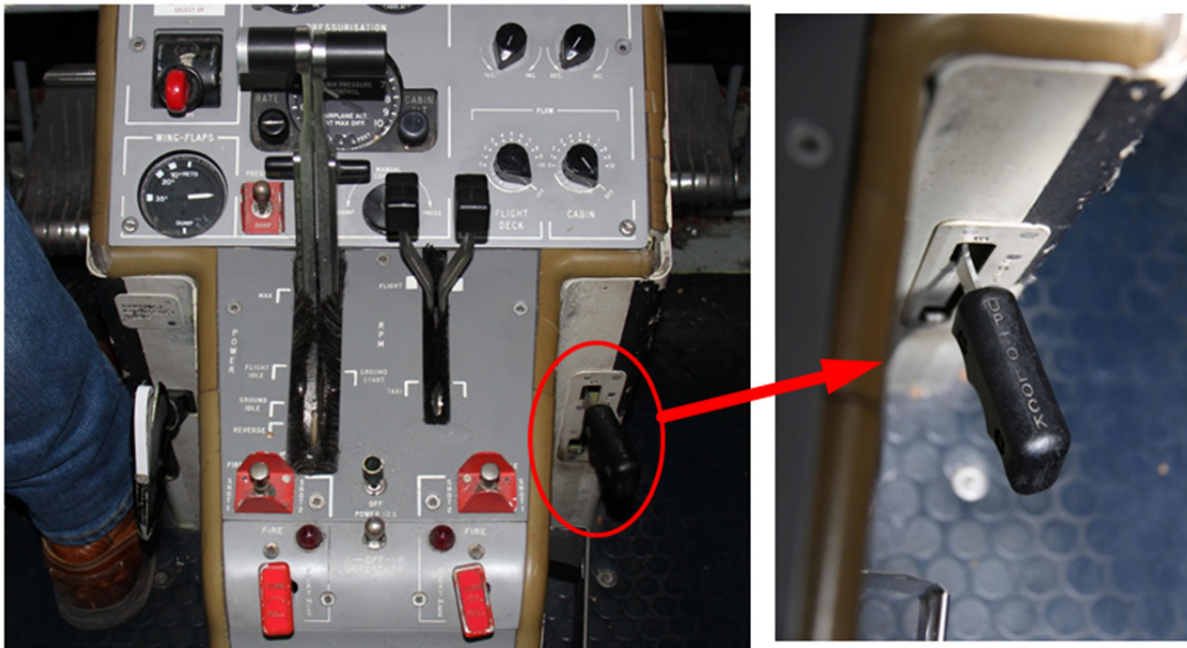
Fig. 6: Cockpit view of the Gust Lock lever

According to the PIC's statement towards the controllers, the Gust Lock lever of the aircraft had been in the locked position (IN) during take-off, so that flight controls

were blocked. However, it was possible to move both power levers beyond the flight idle position.

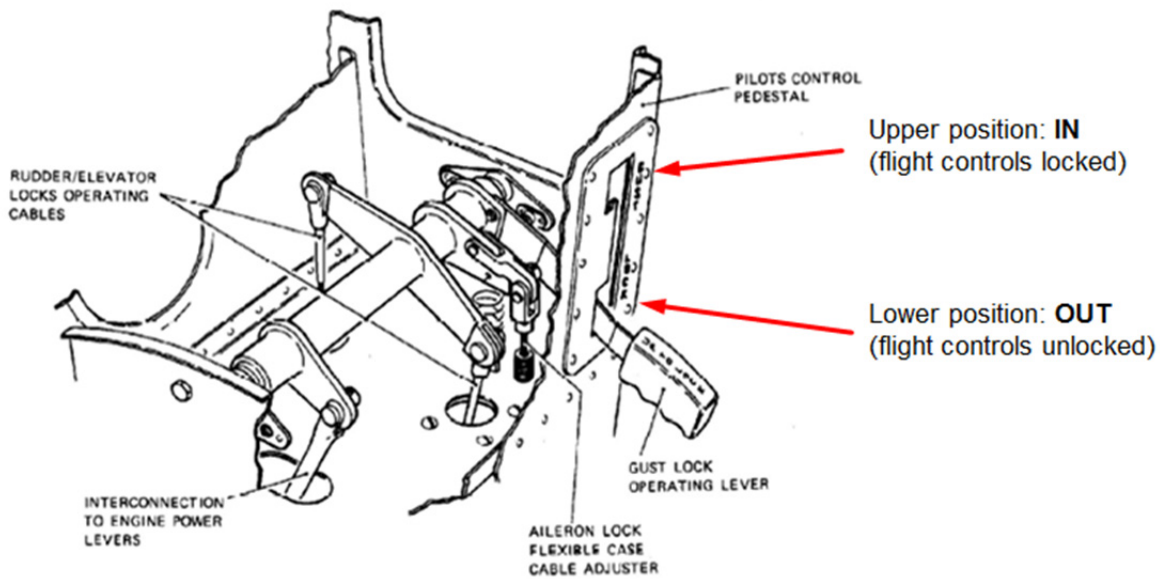
The control surfaces are blocked in their neutral positions via a gust lock lever. This lever is located on the right-hand side of the center pedestal (Fig. 6). If the lever is in the upper position (IN) (Fig. 6 and 7), spring-loaded safety pins block, via corresponding cables and levers, the aileron, rudder and elevator controls. In order to prevent take-off with blocked flight controls it is normally not possible to move both power levers simultaneously beyond the flight idle position. This is mechanically prevented through a special blocking mechanism of bars and levers. Individually the power levers can be moved to the MAX position.

Fig. 7: Gust Lock lever mechanism

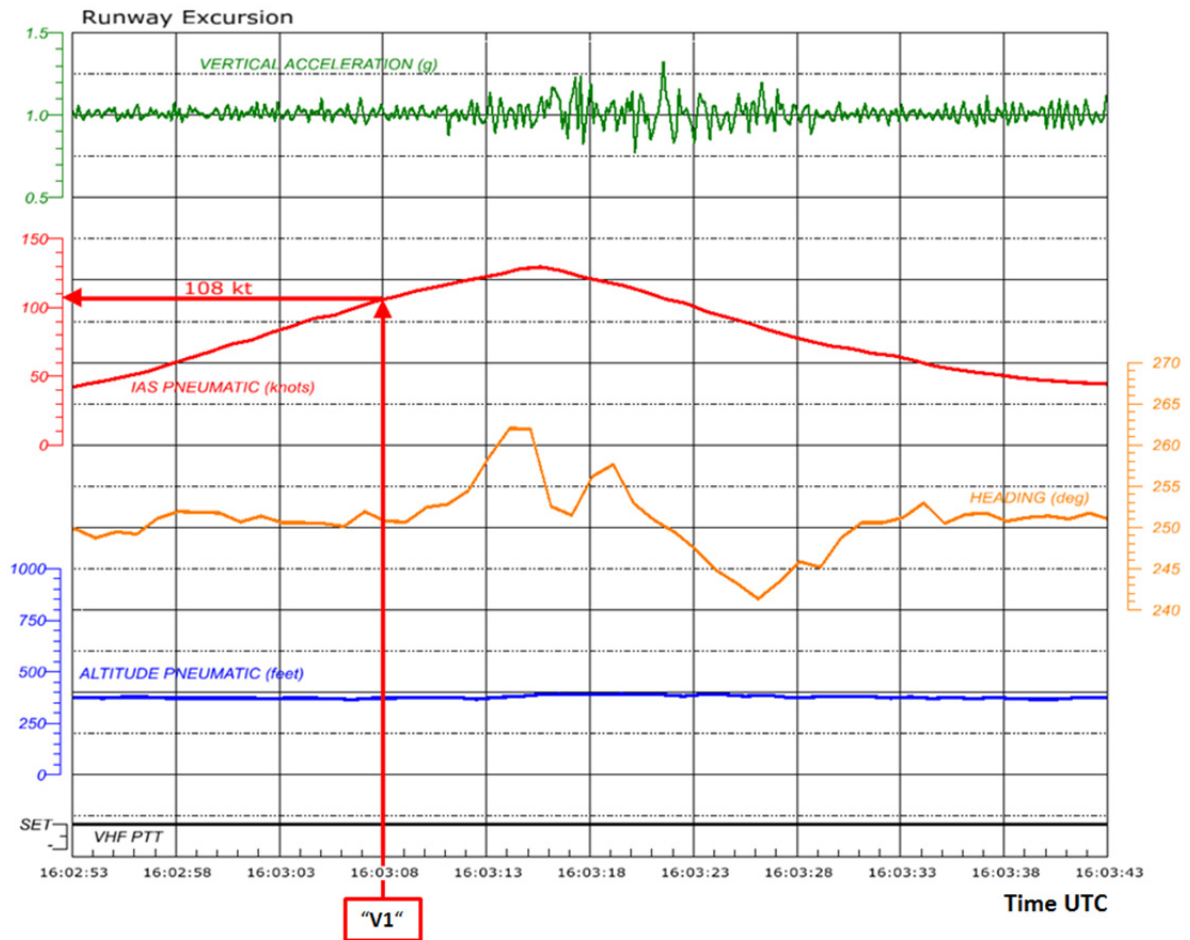
The heading parameter shows that from 1603:09 UTC on, within approximately 5 s the aircraft veered right by about 11° off the runway heading. At 1603:15 UTC, at the time of the rejected take-off, the heading decreased within the next 11 s by 21°. At that time, the PIC counteracted with the nose wheel steering, according to his own statement. At 1603:26 UTC the heading decreases from 241° back to the runway heading.

Between 1603:13 UTC and 1603:27 UTC vertical acceleration increases significantly up to 1.3 g.

Fig. 8: FDR parameters during the rejected take-off

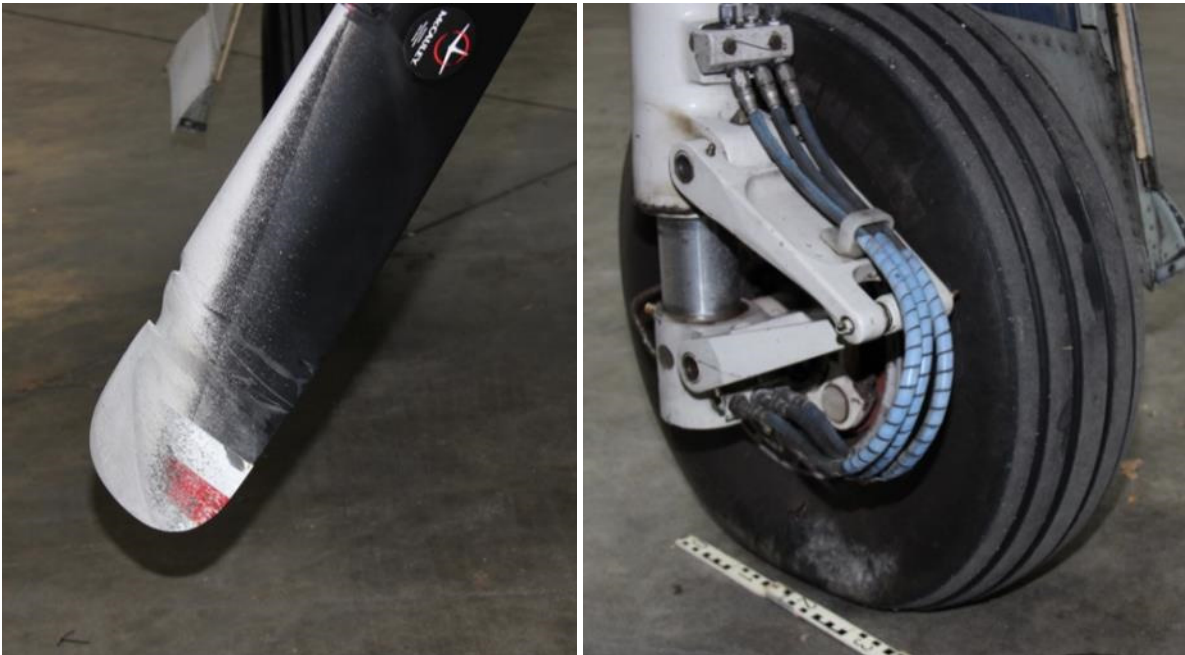
One propeller blade of the right engine (Fig. 9), the left main landing gear tire (Fig. 9), and a small area of the right lower side of the cargo compartment (Fig. 10) were damaged.

Fig. 9: Damage propeller blade and left main landing gear tire

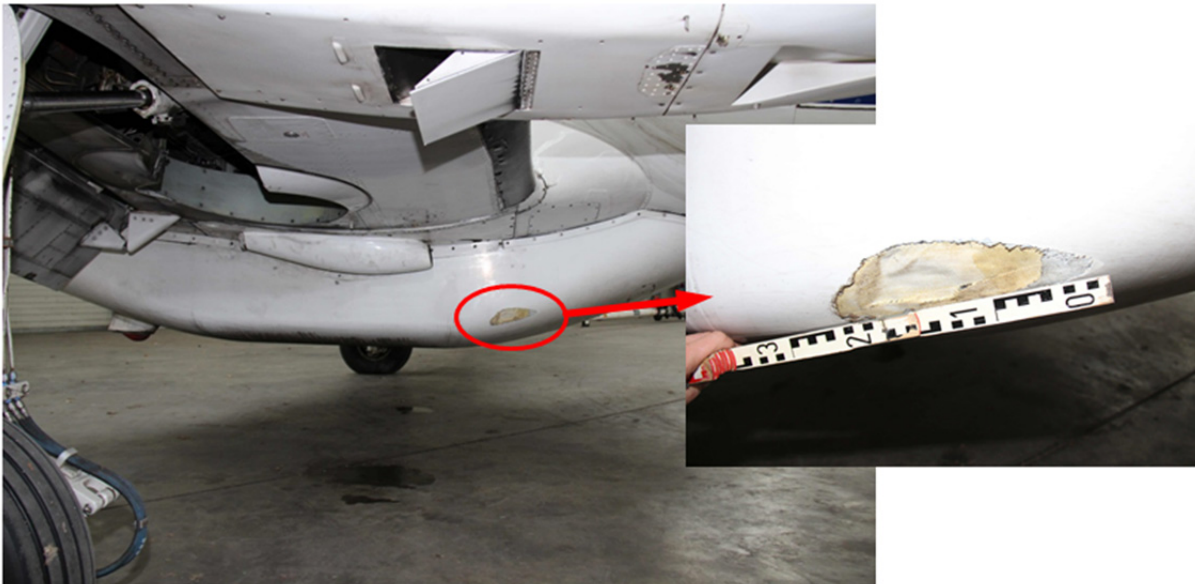
Fig. 10: Damaged area at the lower right side of the cargo compartment

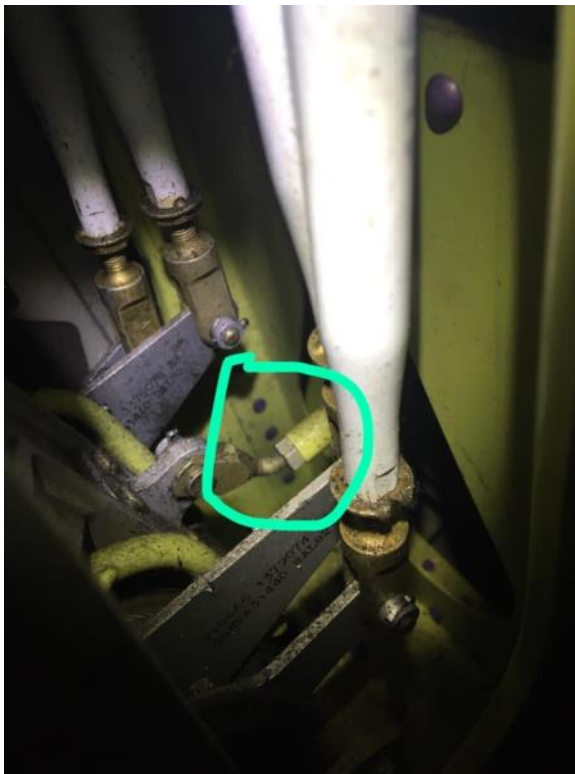
With the Gust Lock lever in the upper position (IN), i.e. blocked flight controls, as it was during the time of take-off, it was possible to move both power levers simultaneously beyond the flight idle position. This should have been blocked mechanically. At the lower area of the center pedestal the fork end of a control rod to block the power lever was located. This fork end was bent by about 45° in relation to the control rod (Fig. 11). Compared to that, Fig. 12 shows an undamaged connection of another aircraft of the same type. The bent connection made it possible to move both power levers simultaneously into the MAX position, even though the Gust Lock lever was in the upper position.

Fig. 11: Bent Connection

The manufacturer assumed that the damage (Fig. 11) was caused by moving the Gust Lock lever into the locked position (IN) while both power levers were above flight idle. The British civil aviation authority published DIGEST 89/D/32 to ensure that the pilots and flight mechanics brought the power levers in the correct position before they lock the Gust Lock system. According to the CAA, they no longer have the document available, as original or copy.

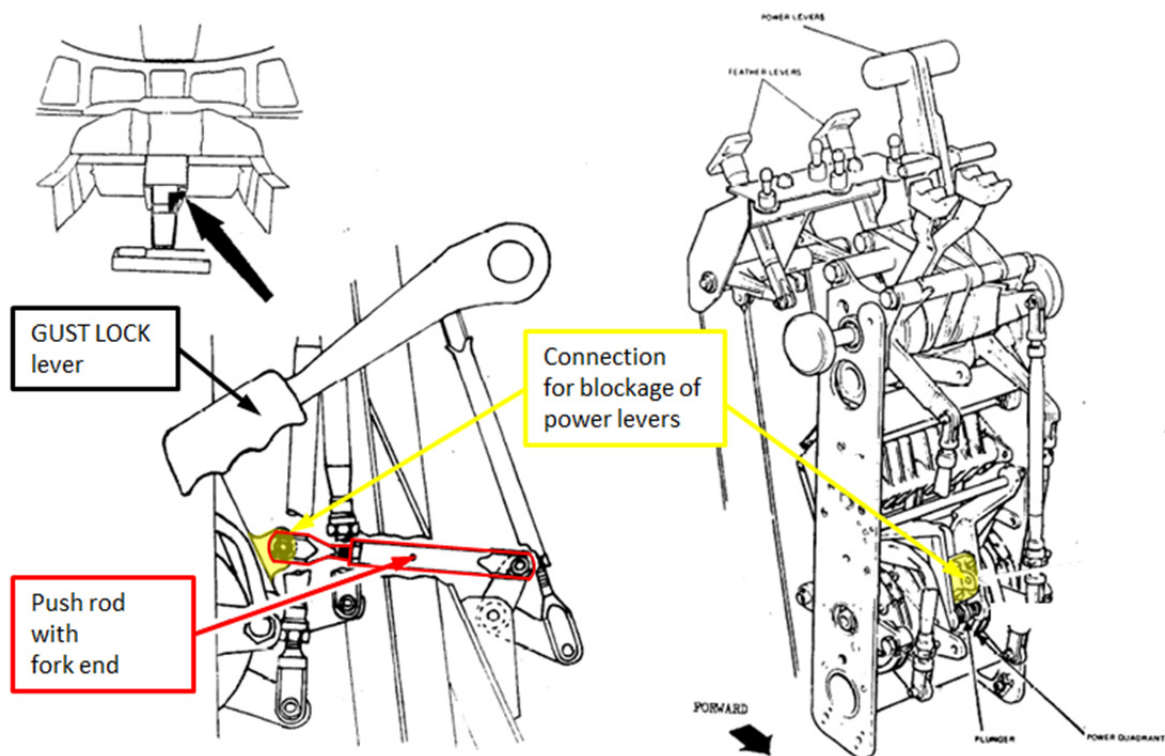
The maintenance organisation of the operator stated that the SB 27JM-5350 had not been implemented in the airplane involved.

Fig. 15: Push rod and connection to lock the power levers

Due to these occurrences, in February 1992 the aircraft manufacturer had published the Service Bulletin (SB) 27JM-5350. With this SB the original push rod (Fig. 15, marked red) including the fork end were replaced by a reinforced version in order to prevent bending of the transition area at the fork end.
