Investigation Report

Type of Occurrence:	Incident
Date:	2 January 2015
Location:	Near Hamburg
Aircraft:	Airplane
Manufacturer / Model:	Airbus / A 321
Injuries to Persons:	None
Damage:	Aircraft not damaged
Other Damage:	None
State File Number:	BFU15-0006-PX

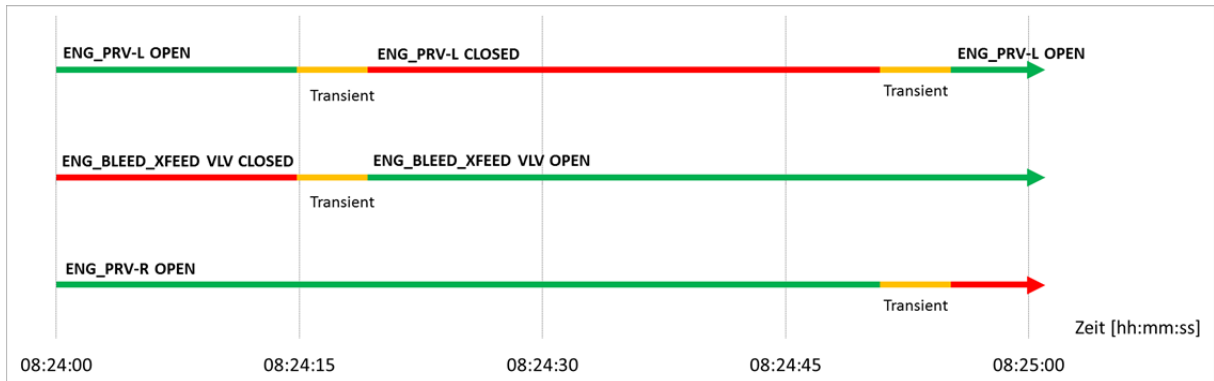
The FDR parameters ENG_PRV-L, ENG_PRV-R, and ENG_BLEED_XFEED VLV indicated the positions of the bleed and cross bleed valves. The position of the valves did not change any more until the landing.

Depiction of the FDR parameters ENG_PRV-L, ENG_PRV-R and ENG_BLEED_XFEED VLV

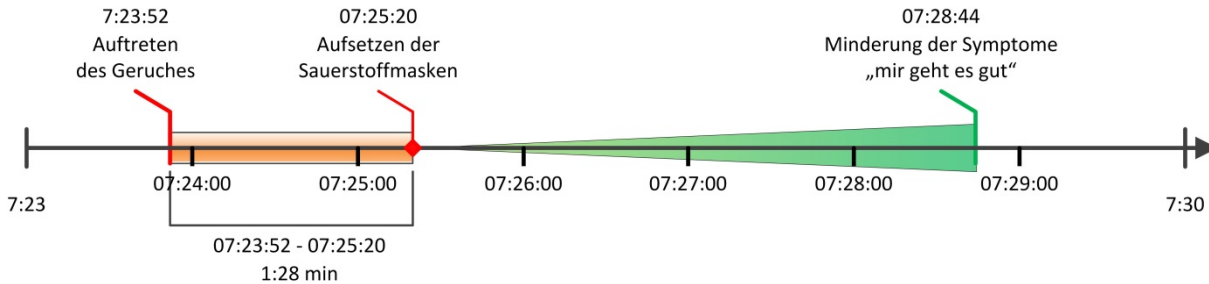
Chronological sequence of the occurrence

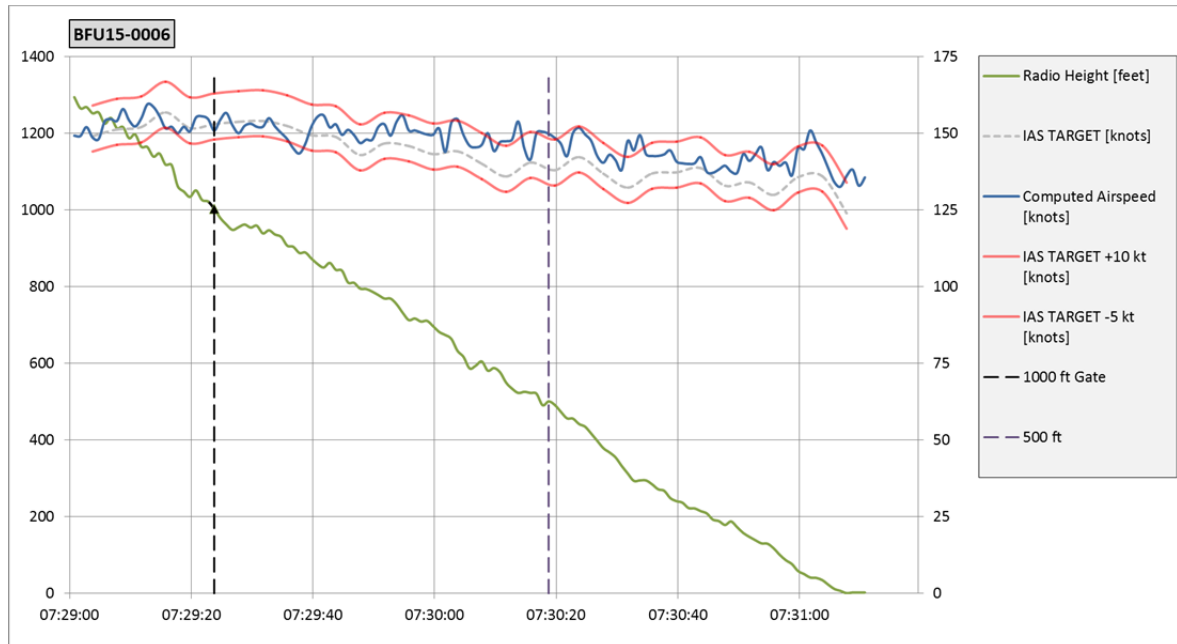
Then the flight crew completed the landing checklist. Based on the landing mass, the reported wind conditions and the configuration of the aircraft target approach speed (IAS-TARGET)²⁰ was 153 kt at a flight altitude of 1,000 ft AGL²¹. While passing this altitude the speed was adhered to with the tolerances permitted in the OM-A. Neither the vertical and lateral ILS deviations nor the allowable maximum sink rate were exceeded. Thus, the criteria for a stabilised approach were adhered to. The analysis of the airspeed shows that the pilot was able to fly the aircraft during the approach within the tolerances.

Analysis of the airspeed during the approach

The recorded acceleration values during the landing were low and comparable to other landings with this airplane. The course of the flight shows that the flight crew was able to accurately control the airplane even while wearing oxygen masks and dealing with the difficult wind conditions during the landing.

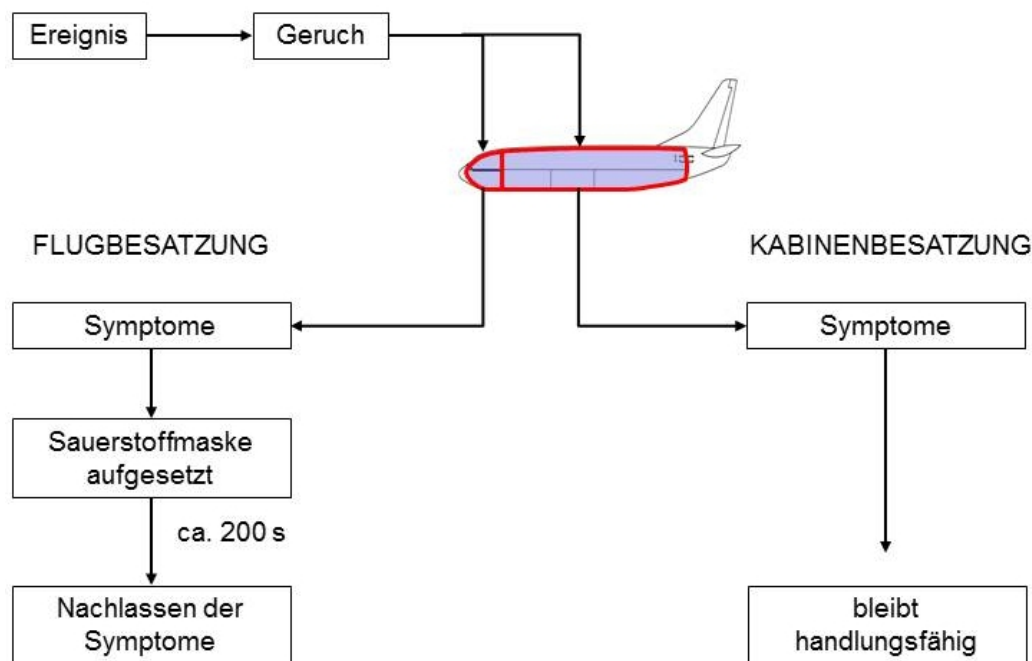
It was not possible for the BFU to determine, which substances in the cabin air had caused the smell and how the symptoms, the crew members had described, could have occurred. This event was characterised by the rapid occurrence of symptoms, but also by their rapid disappearance after a short oxygen dose.

Schematic sequence of the smell event
