# Investigation Report

Type of Occurrence:	Accident
Date:	2 June 2006
Location:	Hamburg
Type of Aircraft:	Fixed Wing
Manufacturer / Model:	De Havilland / DCC 2
Injuries to Persons:	Five occupants fatally injured One occupant seriously injured
Damage to Aircraft:	Aircraft destroyed
Other Damage:	Damage to railway tracks and freight cars
Source of Information:	Investigation by BFU
State File Number:	BFU 3X083-06

Bundesstelle für  
Flugunfalluntersuchung

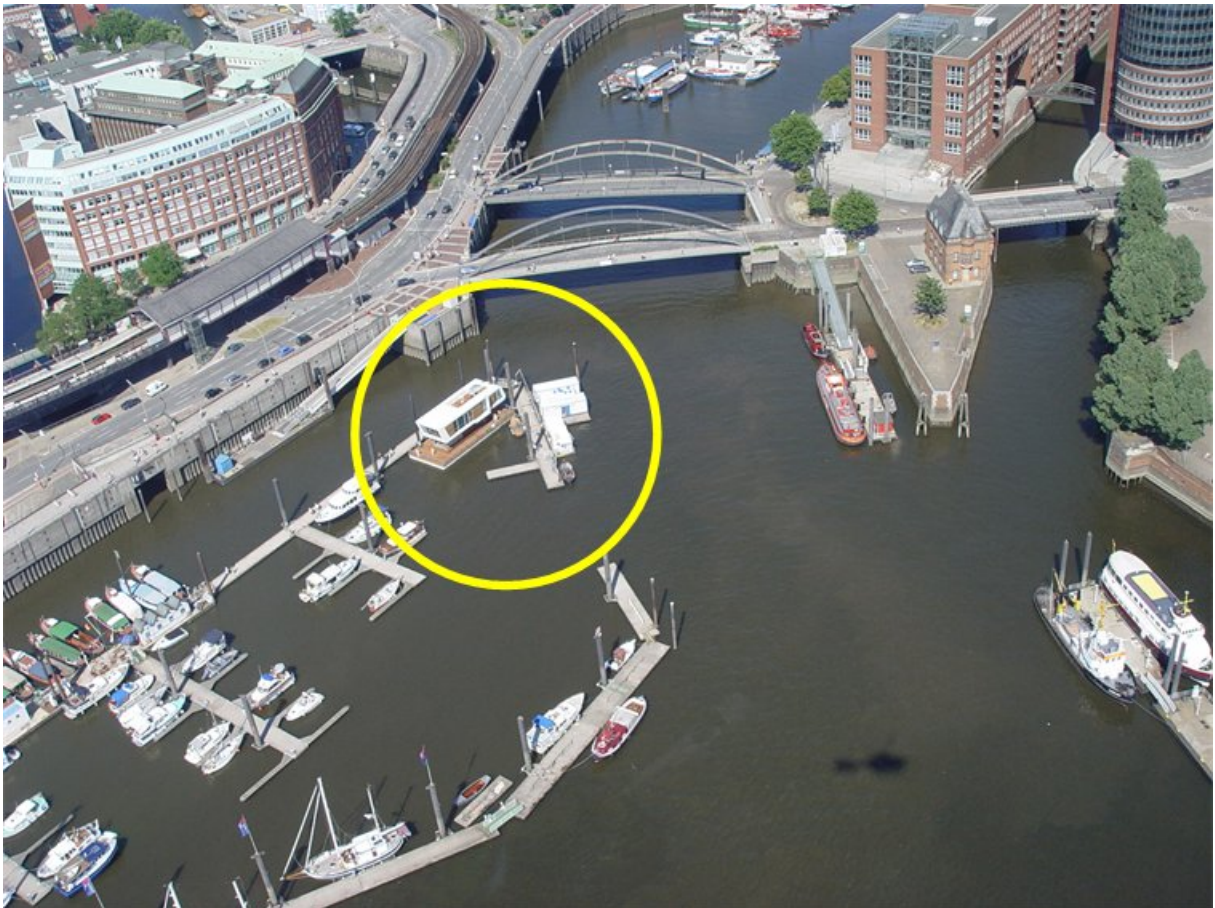
Picture 4: City-Sportboothafen seaplane docking ponton

The water aerodrome operator had installed a passenger departure and arrivals pier in the recreational city yachting harbour zone *am Baumwall*.
