# Investigation Report

Type of Occurrence:	Serious Incident
Date:	6 November 2018
Location:	Clariden, Switzerland
Aircraft:	Transport aircraft
Manufacturer:	Airbus
Type	A340-642
Injuries to Persons:	No injuries
Damage:	None
Other Damage:	None
State File Number:	BFU18-1626-FX

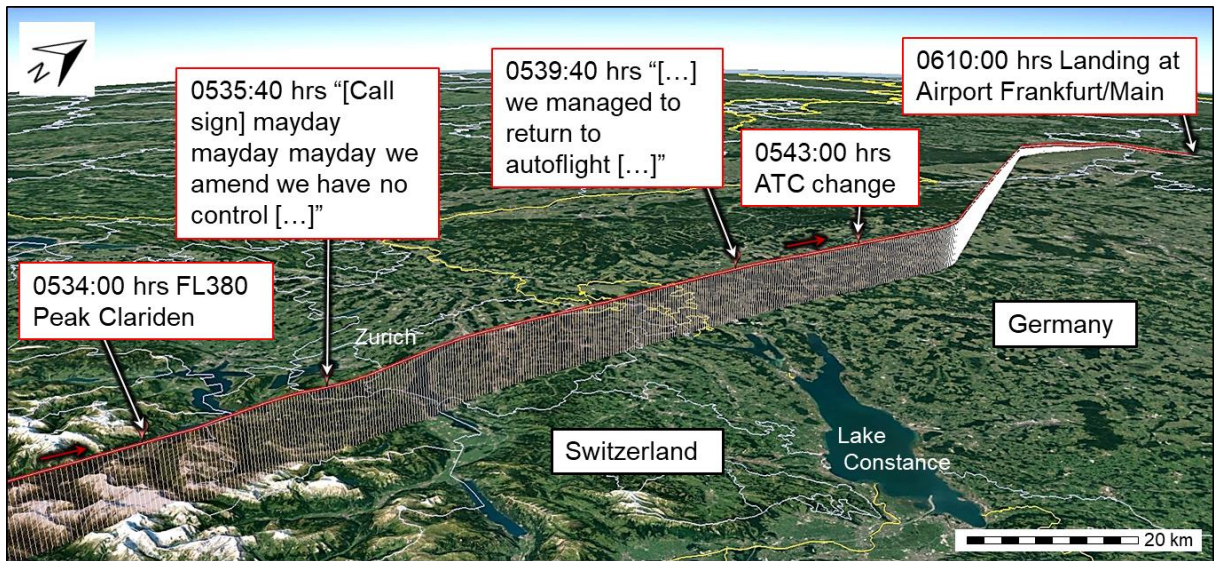
Fig. 2: Course of the flight between the occurrence and the landing at Frankfurt/Main Airport

Figure 2 shows the flight path on a GoogleEarth™ chart with excerpts of the radio communications.

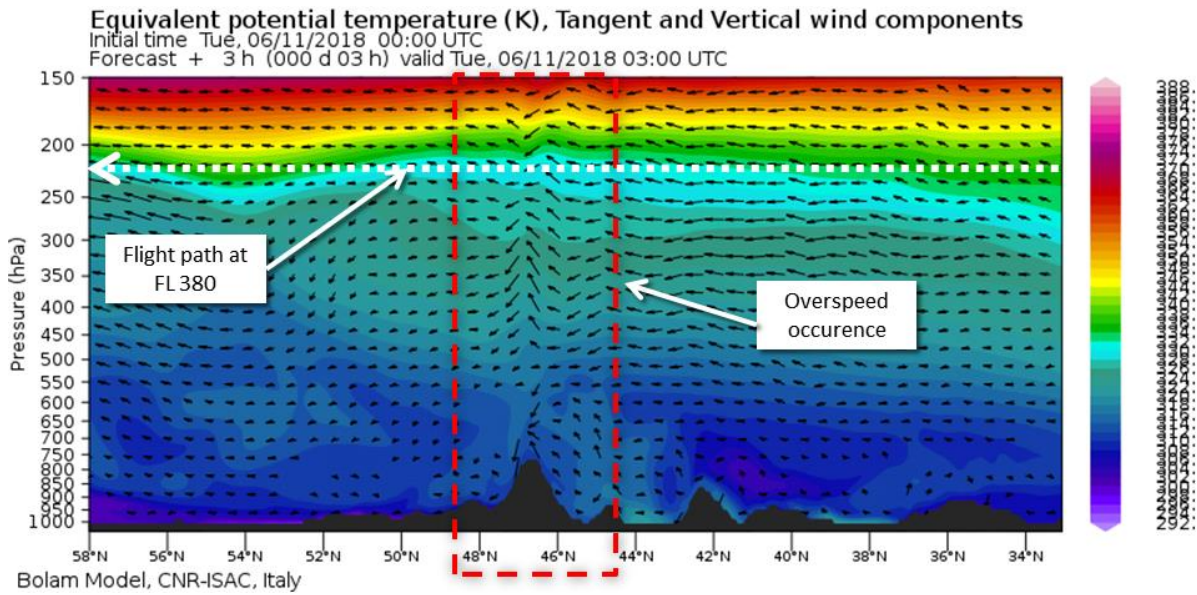
Fig. 9: BOLAM model including vertical wind components

The Institute of Atmospheric Sciences and Climate of the National Research Council of Italy based its forecast on the BOLAM<sup>14</sup> model. It shows clearly that mountain waves were present on 6 November 2018 between 0000 hrs and 0300 hrs in the area of the occurrence (Fig. 9).

This weather chart was not available for pre-flight preparation.
