# Investigation Report

Type of Occurrence: Accident

Date: 11 July 2020

State File Number: BFU20-0502-CX

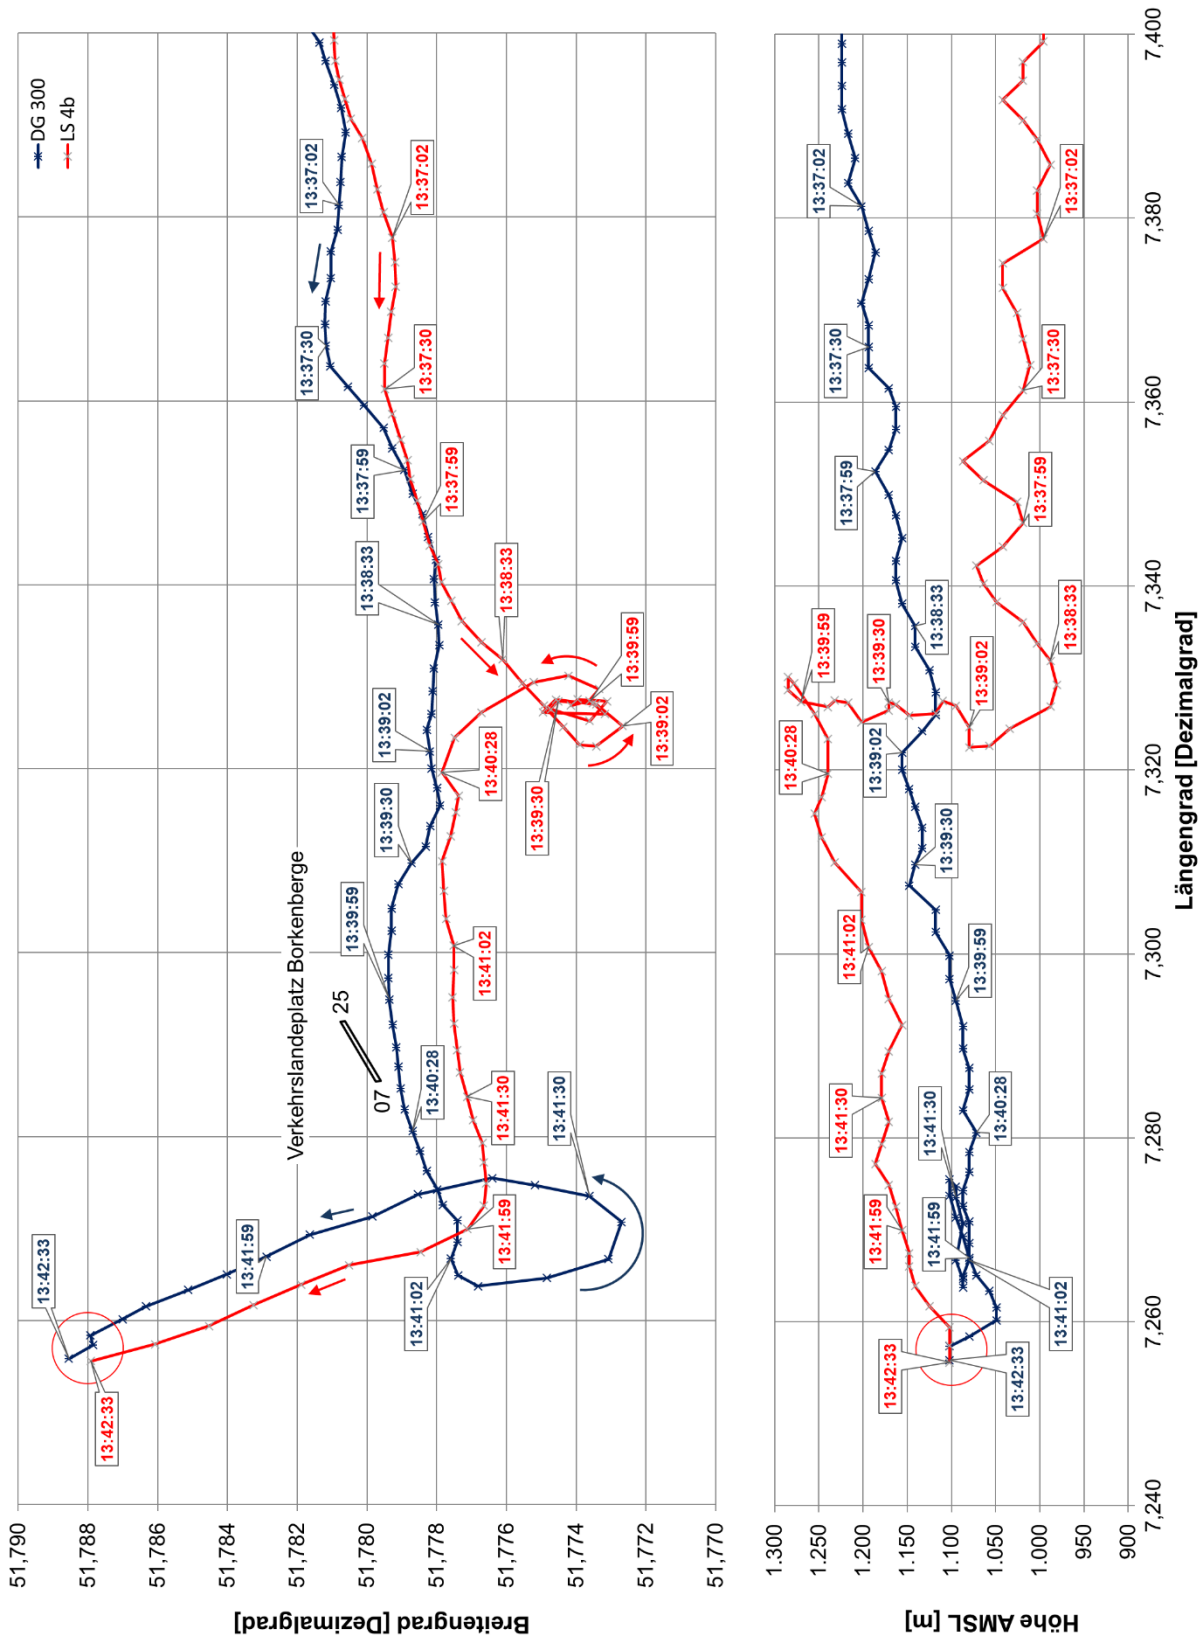
According to the radar data, at about 1338 hrs, both gliders were south-east of Borkenberge Airfield (Fig. 1). At about 1338:30 hrs, the LS4-b began three left circles, ended them at about 1,280 m AGL and continued west with a distance to the DG-300 of about one minute. At the time, the DG-300 was about 150 m below and to the right of the LS4-b.

At about 1342:30 hrs and approximately 2 km north-west of Borkenberge Airfield at about 1,100 m AGL, both gliders collided. The DG-300 crashed to the ground. After the collision, the LS4-b pilot left the glider with the emergency parachute. It was found with open leg harness about 140 m south-east of the LS4-b pilot's body in a grain field.

Fig. 1: Flight paths (LS4-b red / DG-300 blue)

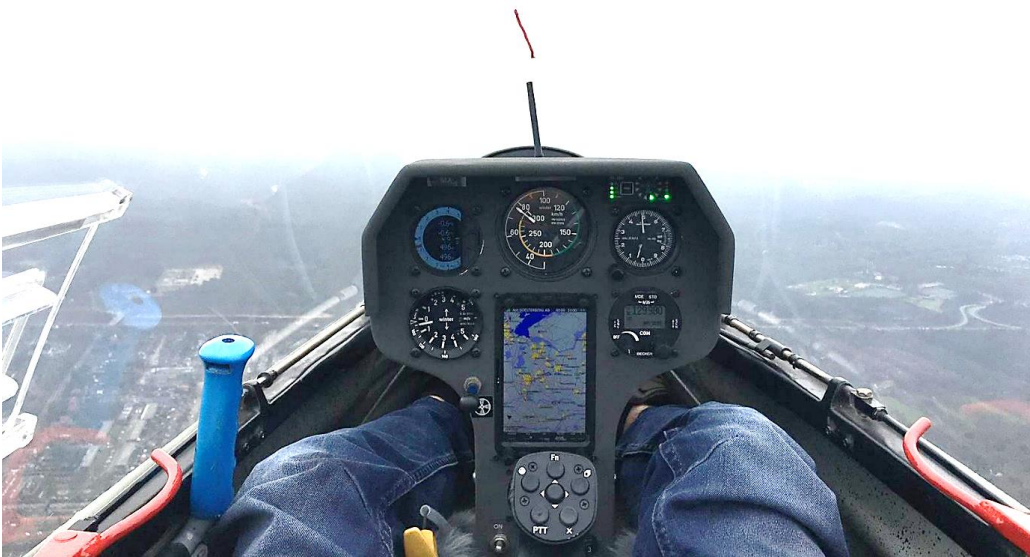
The LS4-b was equipped with a transponder, a LX 9050 navigation system and FLARM (Fig. 2).

Fig. 2: Cockpit of the LS4-b with FLARM indication (right upper corner)

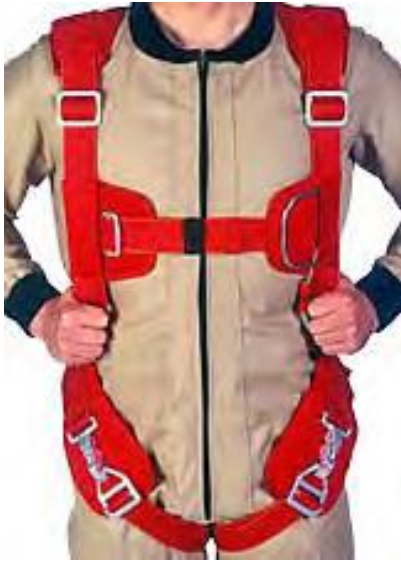
The emergency parachute was fitted with the leg harness type „Conventional Harness“ (Fig. 3).

Fig. 3: Fastening the „Conventional Harness“

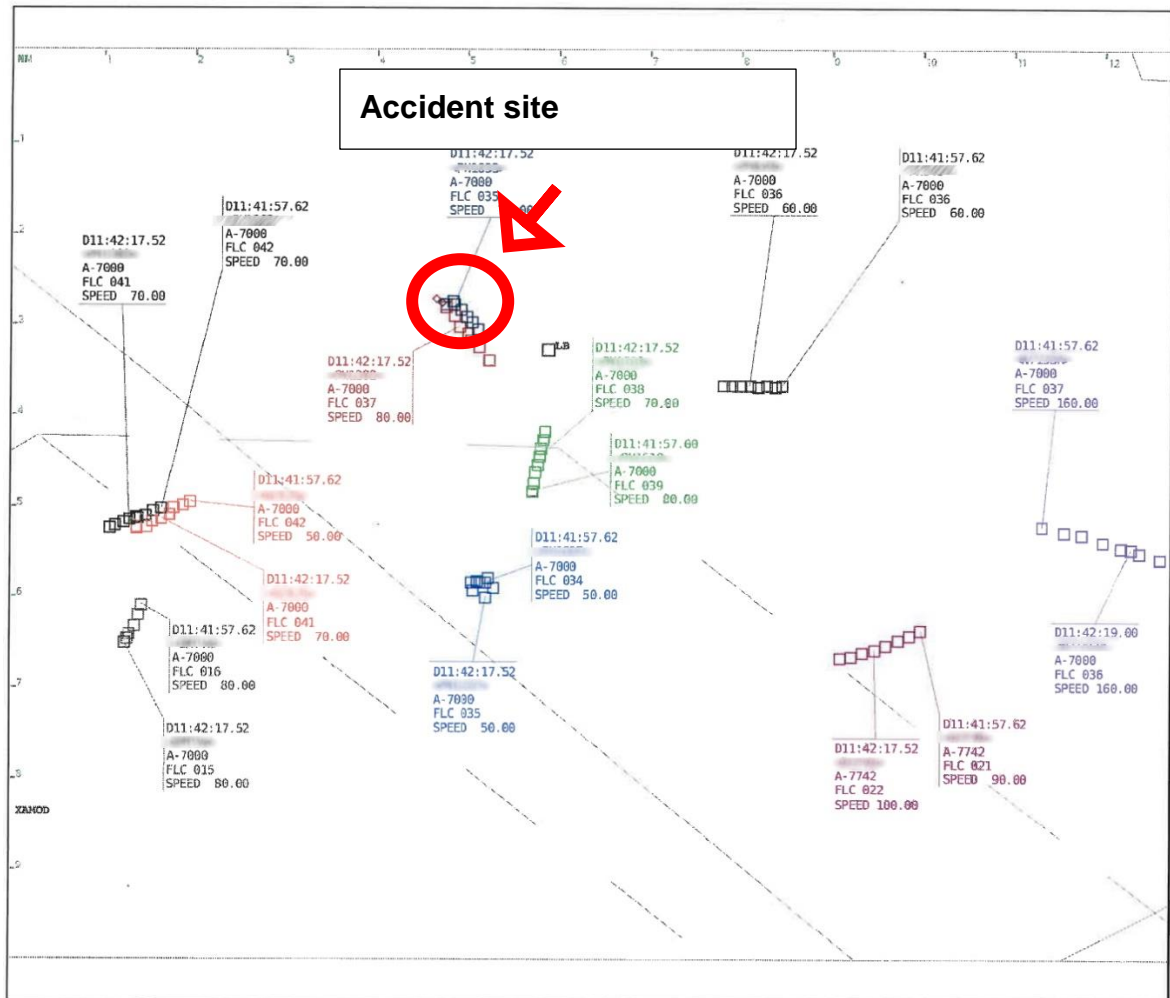
At the time of the accident, at about 1342 hrs, several aircraft were in the air around the accident site. On the airspace depiction of the civil air navigation service provider, 10 targets with transponder signals were visible (Fig. 6).

Fig. 6: Radar data of the area of the accident (at about 1342 hrs)

In Figure 6 the primary targets without transponder signal, e. g. gliders or ultralights, which are only equipped with FLARM, are not depicted. The BFU had available five FLARM data sets of gliders which were not equipped with a transponder or whose transponder had not been switched on. Therefore, the actual number of aircraft in the vicinity of the accident site was significantly higher as depicted in Figure 6.

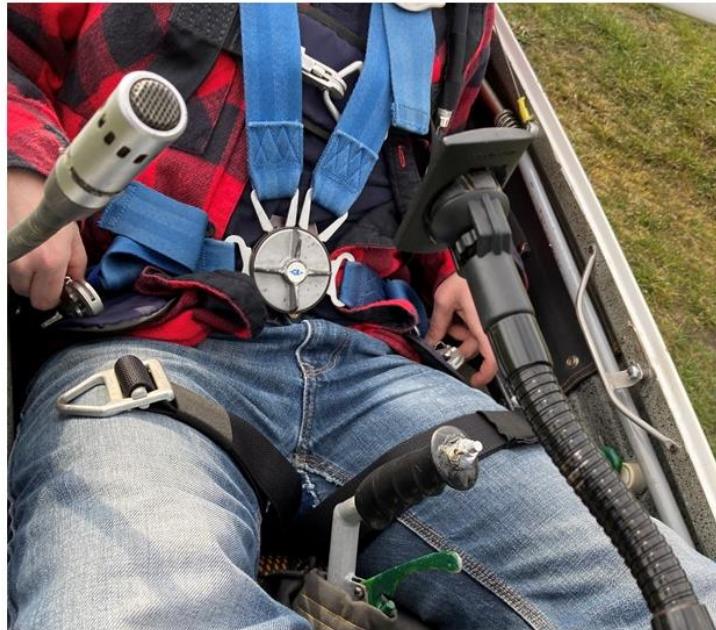
In order to verify the statement, whether the buckle of the harness has to be opened to urinate, the BFU conducted tests with a LS4-b (Fig. 12). It was determined that opening the buckle was not absolutely necessary to being able to open the pants to urinate.

Fig. 12: BFU test with a LS4-b

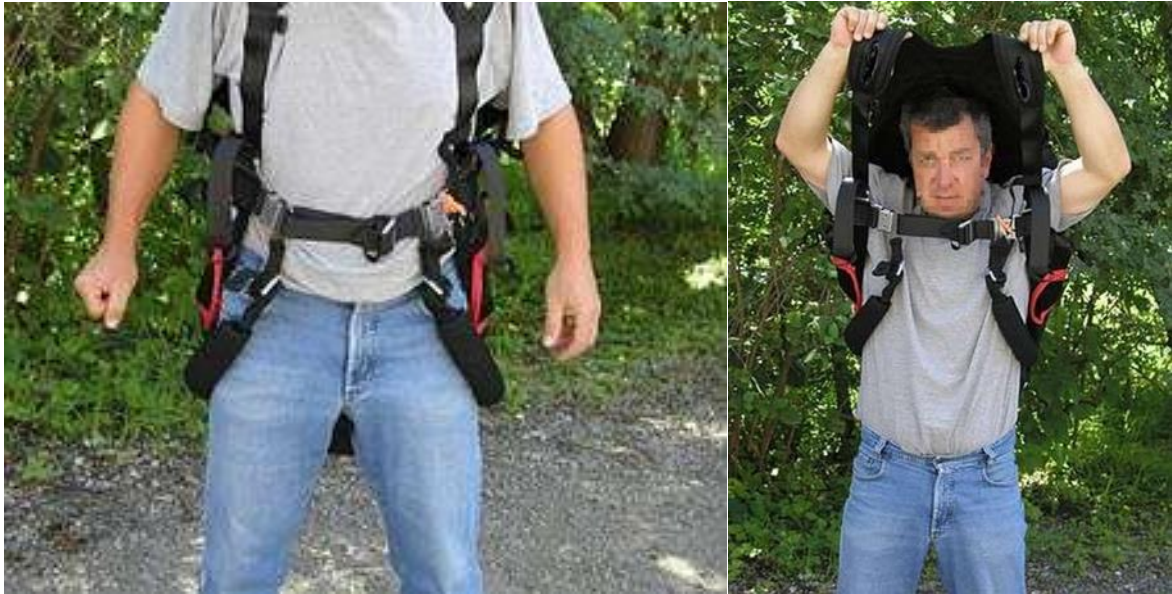
Publications of the Deutsche Gleitschirm- und Drachenflugverband e. V. (DHV) show that accidents where the leg harness was not closed or incorrectly guided resulted in several fatal drops. Tests showed that falling out of the harness was very easy.

Fig. 13: DHV Safety Information Open Harness, 2006

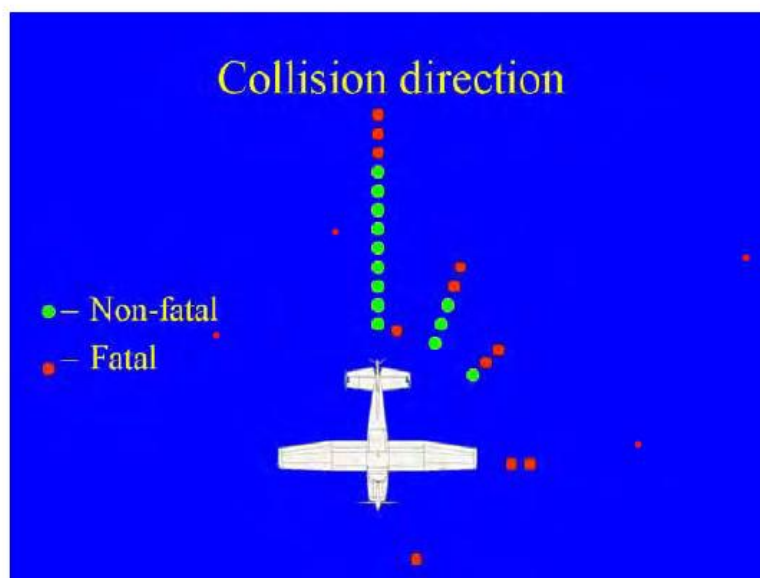
The ATSB study RESEARCH REPORT B2003/0114, Publication date 22/05/2004<sup>8</sup>, lists high workload and line-of-sight obstructions for one or both pilots as contributing factors. The study shows that most collisions, where both aircraft approach one another from the same or similar direction (less than 30°), occur from behind (Fig. 13).

Fig. 13: ATSB study with the distribution of the collision direction
