Interim Report

Type of Occurrence:	Serious incident
Date:	8 October 2019
Location:	Münster/Osnabrück Airport
Aircraft:	Airplane
Manufacturer / Model:	BAe Systems / Jetstream 32
Injuries to Persons:	No injuries
Damage:	Minor damage to aircraft
Other Damage:	One runway edge light and an information sign damaged, crop damage
State File Number:	BFU19-1422-EX
Date of Publication	December 2019

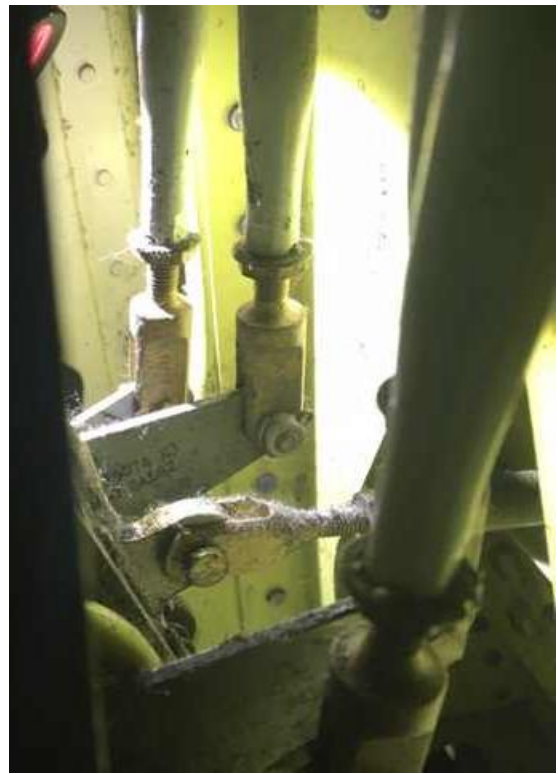
Fig. 12 Connection intact

With the Gust Lock lever in the upper position (IN), i.e. blocked flight controls, as it was during the time of take-off, it was possible to move both power levers simultaneously beyond the flight idle position. This should have been blocked mechanically. At the lower area of the center pedestal the fork end of a control rod to block the power lever was located. This fork end was bent by about 45° in relation to the control rod (Fig. 11). Compared to that, Fig. 12 shows an undamaged connection of another aircraft of the same type. The bent connection made it possible to move both power levers simultaneously into the MAX position, even though the Gust Lock lever was in the upper position.
